Memorandum

Re: City of Mequon Capital Improvement Plan Stormwater Study

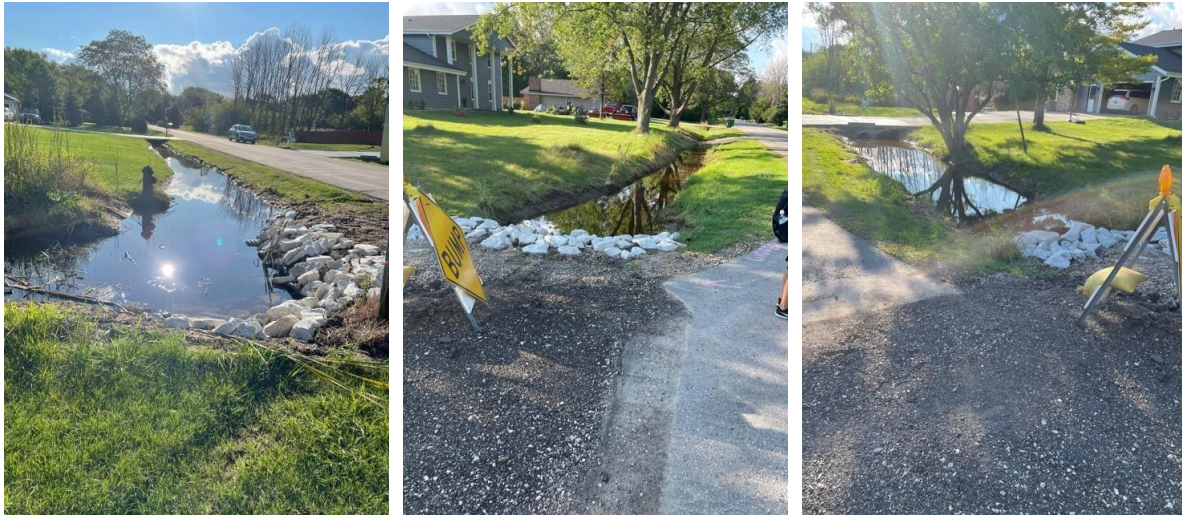
Figure 1
Water Levels Shown in Photographs Following the August 28-29 Precipitation Event

Anchor QEA understands that the high water levels were primarily a concern near the intersection of West Revere Road and North Prairie View Lane. Images of the ditches near the intersection were forwarded to the engineering team in an e-mail dated September 9, 2021 (Figure 1). The photographs show water below the road surface and contained to the ditches. Conversations included in the same e-mail chain indicated that water was confined to the ditches at all times and never crested the road.

Left to right: View looking east along northern edge of Revere Road; looking south along eastern edge of Prairie View Lane; looking east along southern edge of Revere Road
Source: E-mail from City of Mequon to Anchor QEA dated September 9, 2021

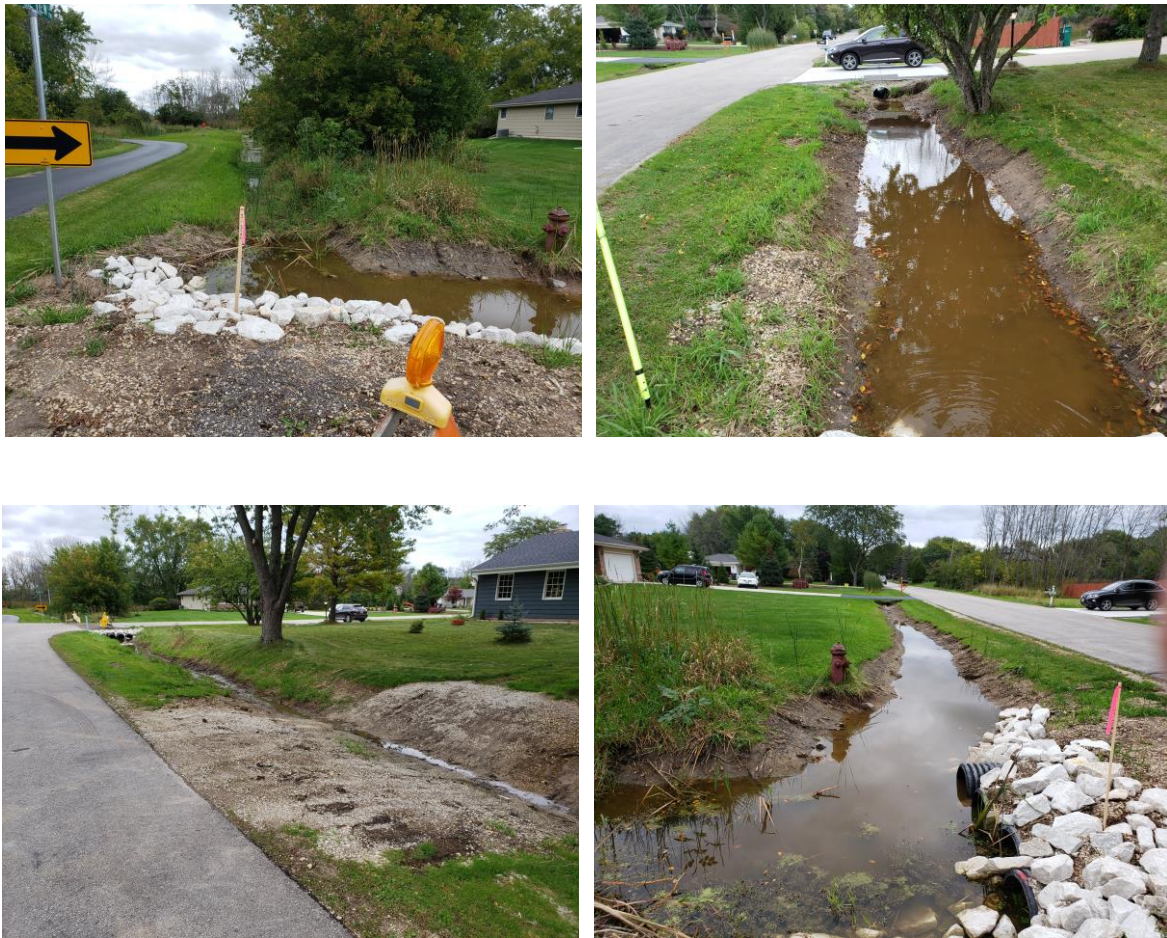
Figure 2
Photographs of North Prairie View Lane and West Revere Road in Mequon, Wisconsin Taken on September 21, 2021 by Anchor QEA

Anchor QEA staff returned to the site on September 21, 2021 to evaluate field conditions. Water surface elevations (WSEs) measured in the ditches were approximately 660.7 ft above the North American Vertical Datum of 1988 (NAVD88). Depths were approximately 0.6 ft near the culverts at the upstream (south) side of Revere Road and 1.3 ft at the downstream (north) side of Revere Road.

Clockwise from top left: View looking north from intersection along eastern edge of Prairie View Lane; looking east along south side of Revere Road; looking east along north side of Revere Road; looking northeast toward intersection from Prairie View Lane

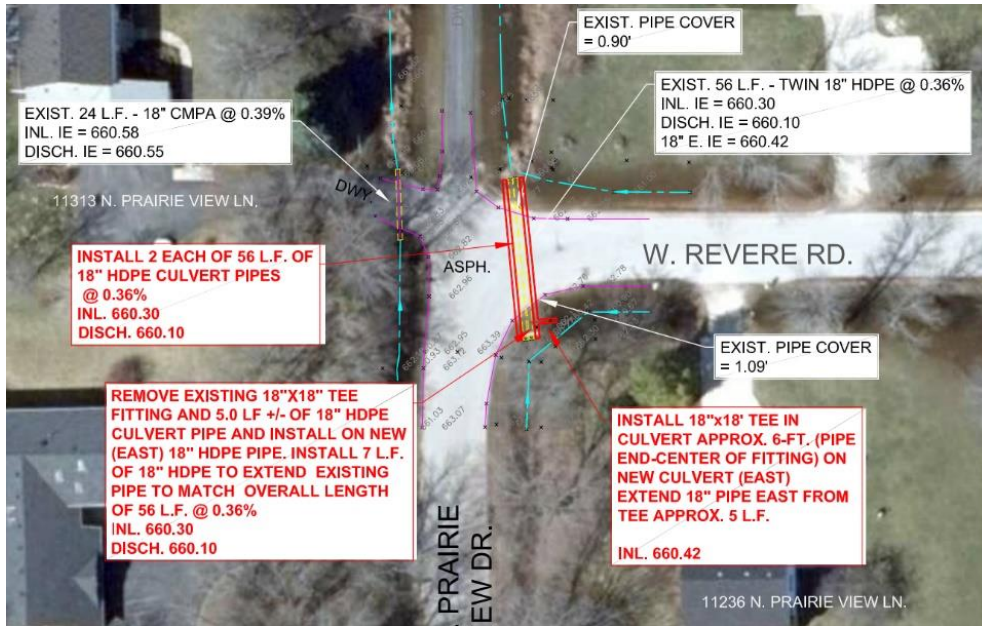
Figure 3
Plan Drawing Prepared by City of Mequon for Culvert Installation

Anchor QEA reviewed the plans provided by the City and compared them to the installed conditions (Table 2). The as-built inlet elevations are approximately 0.2 ft lower than drawn. Outlet inverts were installed approximately 0.1 ft lower than drawn.

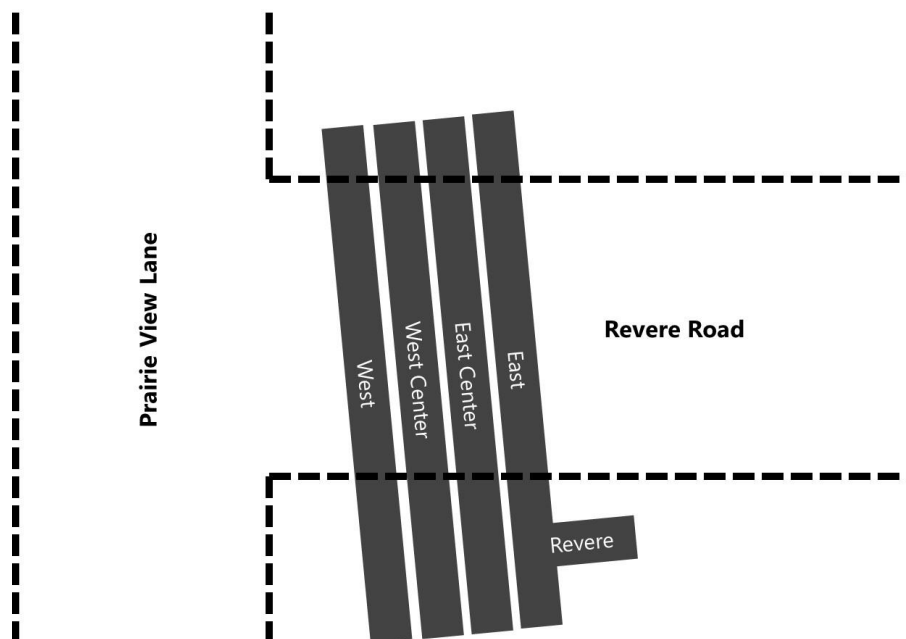
Figure 4
Schematic Layout and Naming Conventions for Culverts at Prairie View Lane and Revere Road Intersection

The field team also investigated the culverts at the intersection. The culverts consist of four pipes running parallel to Prairie View Drive and under Revere Road. There is also one culvert draining the south side of Revere Road that connects to the eastern culvert and flows under Revere Road to the north as shown in construction plans prepared by the City (Figure 3 and Figure 4). Each culvert was measured to be an 18-inch diameter corrugated plastic pipe (CPP).

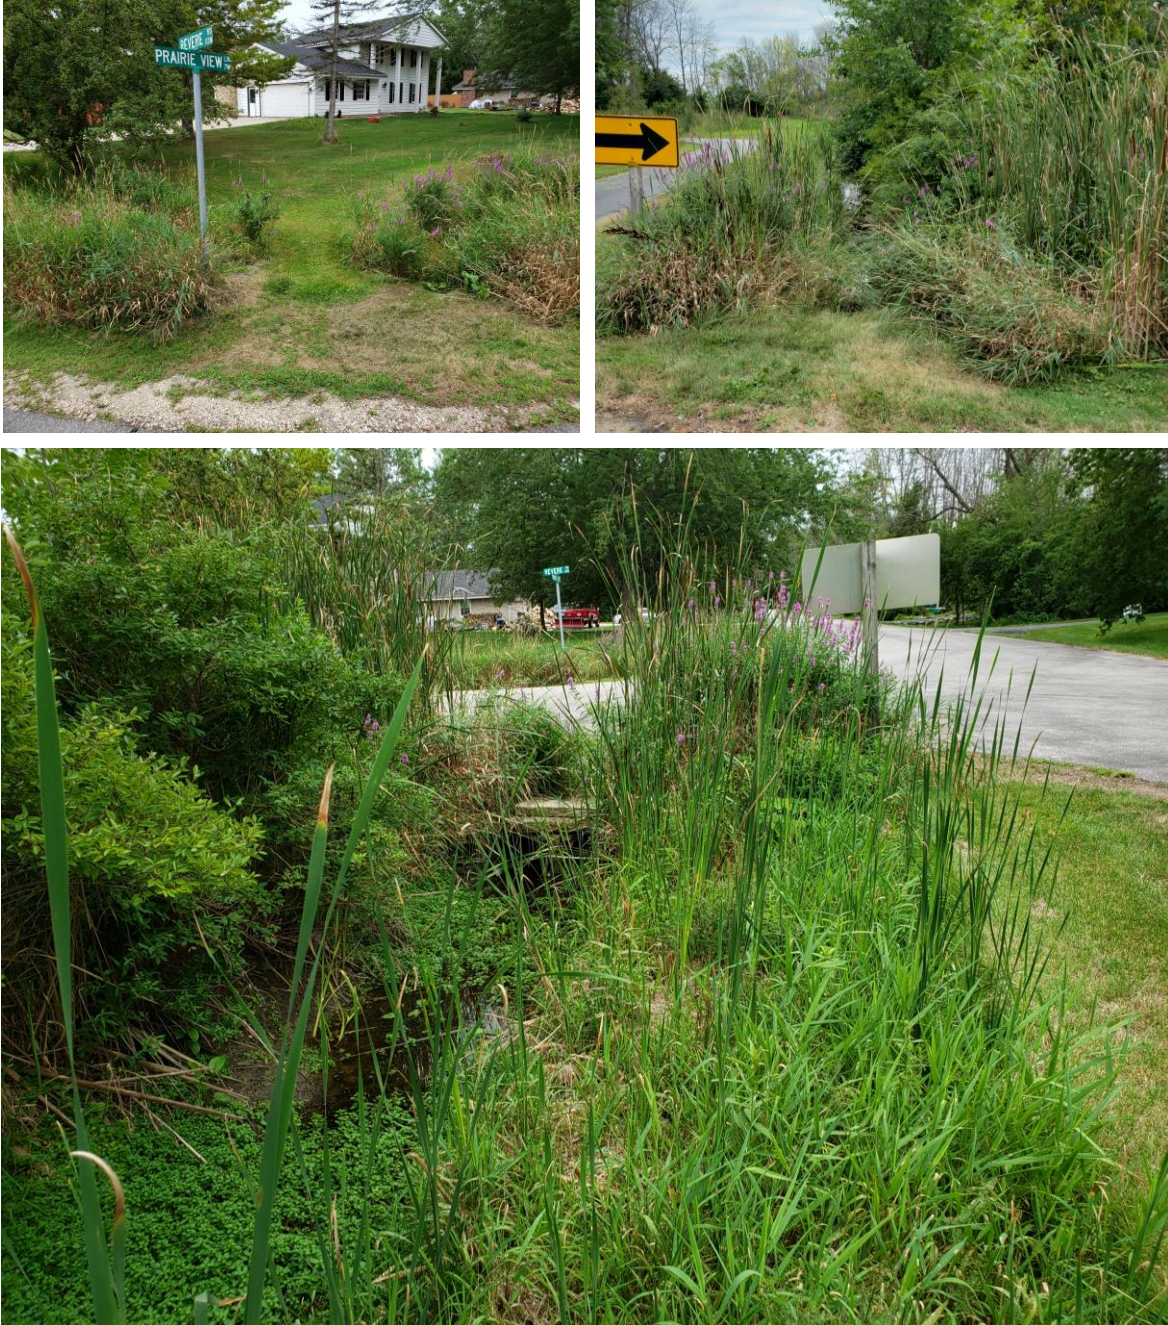
Figure 5
Photographs Taken by FreshWater Engineering During September 1, 2020 Site Visit

It is possible that the water levels *appear* worse following culvert installation regardless of actual WSE. During the September 1, 2020 site visit by FreshWater Engineering, the ditches in question contained a significant volume of water. One major difference between the ditch conditions at that time and the current conditions is a noticeable lack of vegetation following construction. Because the vegetation was largely overgrown in and around the ditches, it obscured the view of any water in them (Figure 5). Another difference is that near the culverts, the ditches have been widened. Now that the vegetation is gone and the ditches are wider, the water in them is far more visible, which likely makes it appear more significant than before culvert installation. However, there is no reasonable mechanism by which the culverts have caused higher water levels.

Images show the ability of vegetation to hide water present at the site during the September 2020 site visit performed by FreshWater Engineering. Compare these images to Figure 2.
Clockwise from top left: View looking southeast from the intersection of Prairie View Lane and Revere Road; looking north from the intersection along the eastern edge of Prairie View Lane; looking south toward the intersection along the eastern edge of Prairie View Lane
