Prepared for:
City of Mequon
Engineering Department
11333 N. Cedarburg Road
Mequon, WI 53092

Prepared by:
AECOM
1555 N RiverCenter Dr. Suite 214
Milwaukee, WI 53212
60189482
June 2014

Final Report

City of Mequon, Wisconsin Pilot Private Property Infiltration and Inflow Reduction Program Study

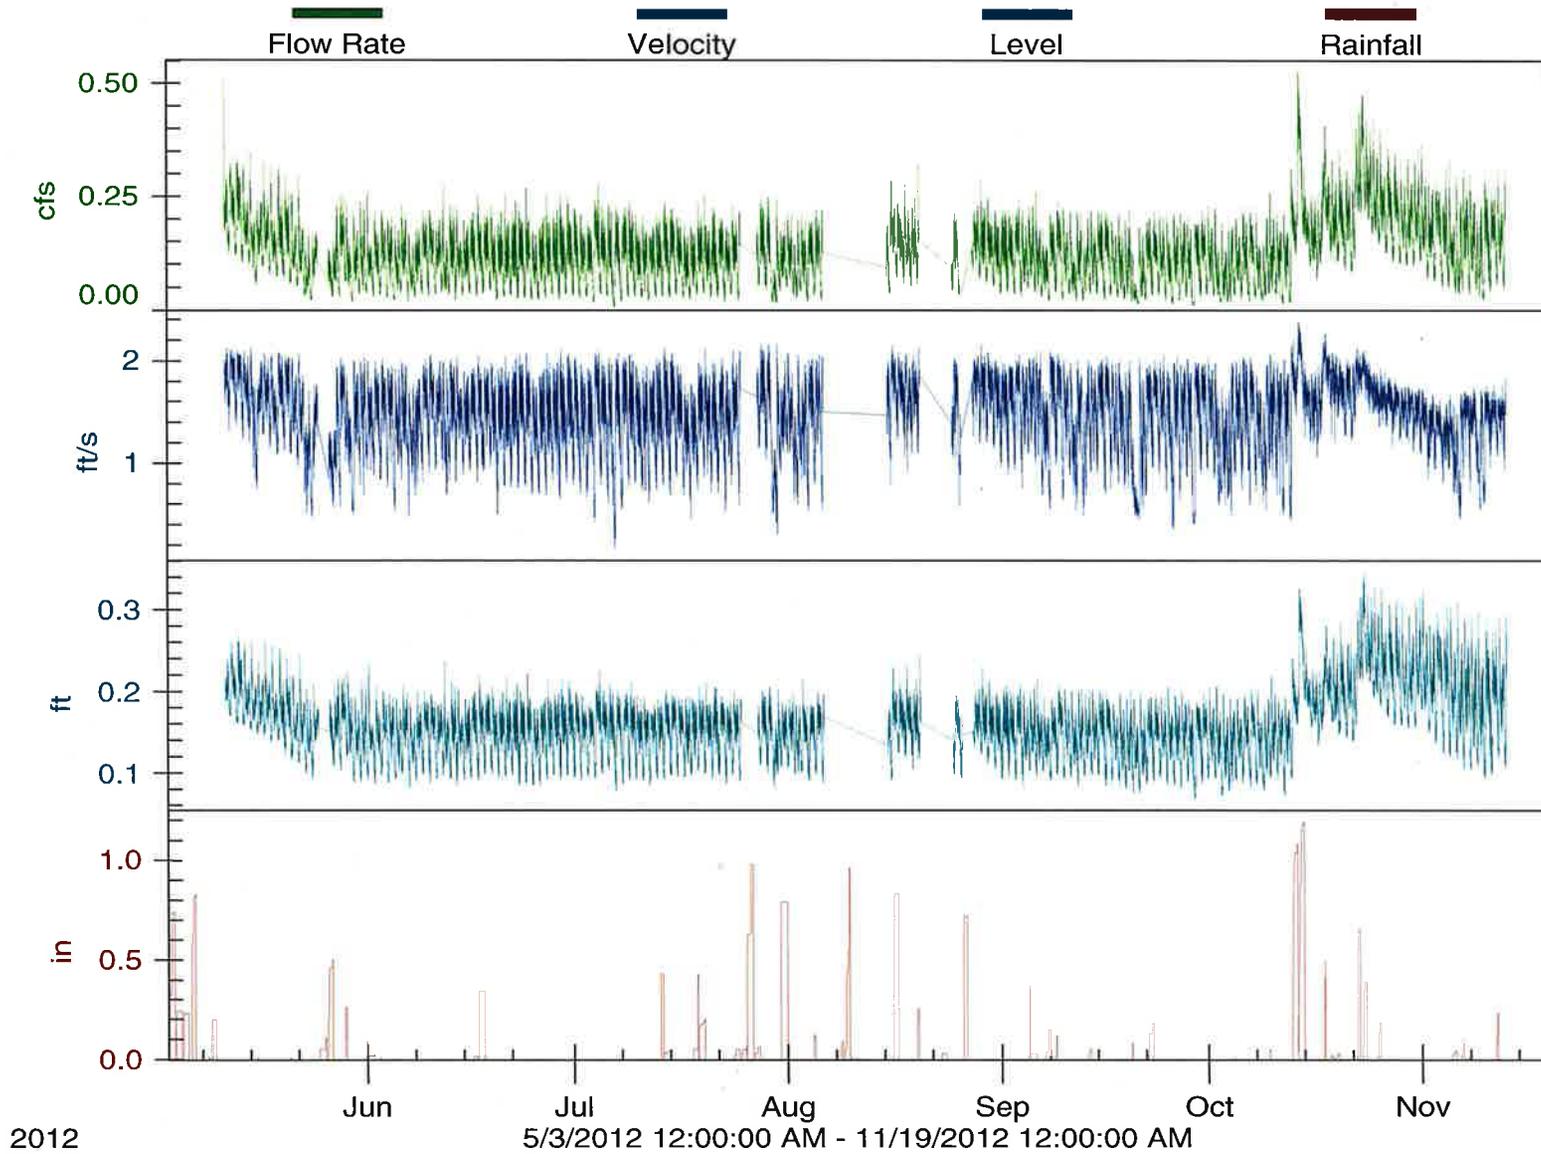
ME3080 Yvonne Dr and Fluerdelis

For the 2012 analysis, rainfall that fell on October 13 and 14, 2012 was the only event that caused a reaction in the sanitary sewers tributary to each meter. Graphs for the 2012 data showing flow rate, velocity, flow depth, and rainfall are presented in Appendix C.

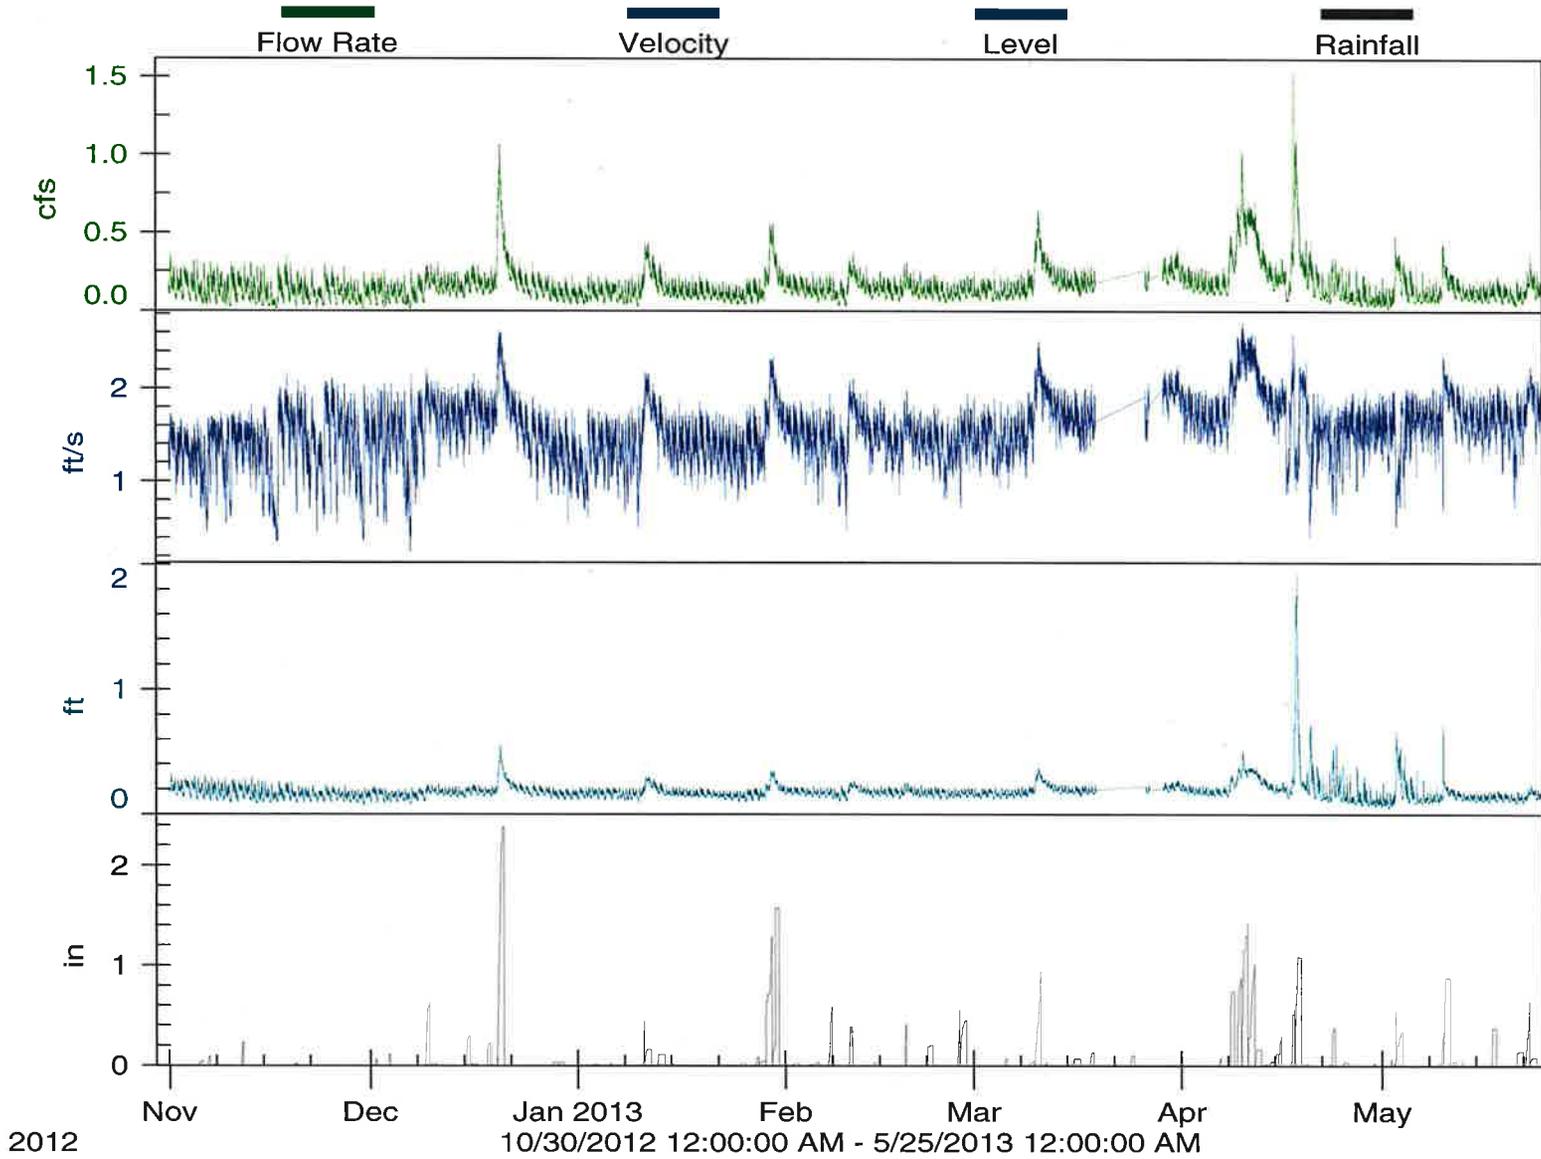
ME3080 11-1-12 to 6-3-13

The rain event of April 8 through April 11, 2013 caused the greatest peaking factors and RDII at three of the meter sites: 113-081, 625-003E, and 625-003E, the rain event of December 12, 2013 caused the greatest peaking factor and RDII at two of the meter sites: 113-028 and 623-031. The April 17 and April 18, 2013 rain events cause the greatest peaking factor and RDII at meter site 113-080. However, all three rain events caused a significant reaction in the sanitary sewer. Graphs for the 2013 data showing flow rate, velocity, flow depth, and rainfall are included in Appendix D.

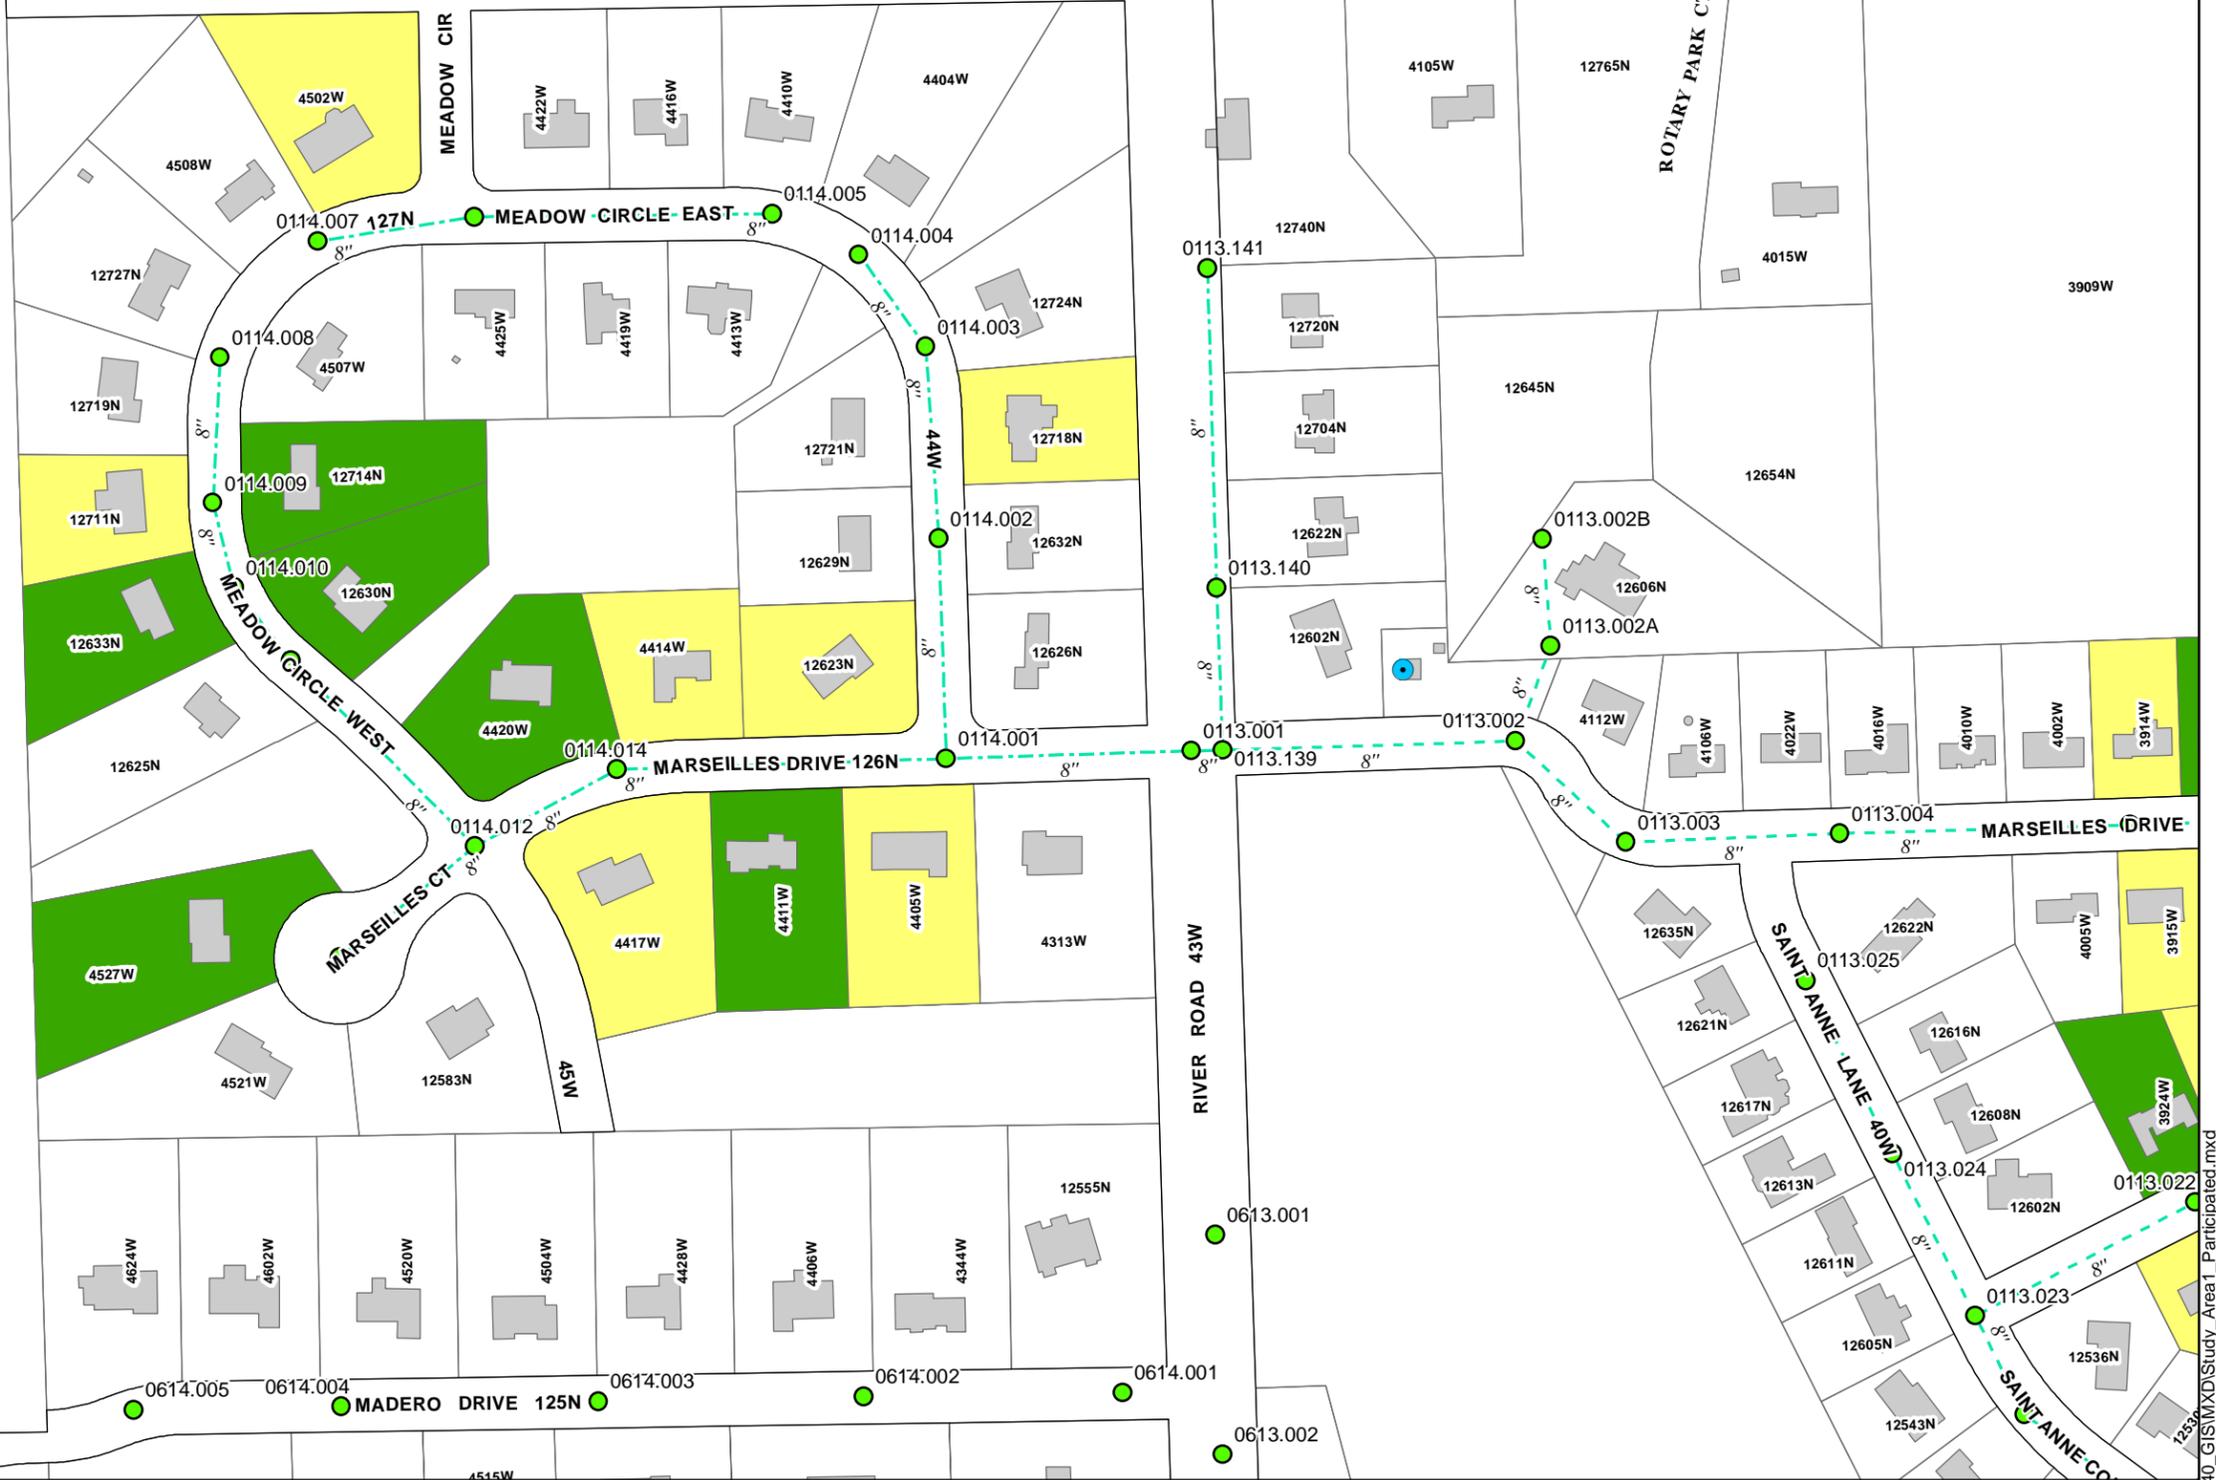
Study Area 1

Results: During the 2009 mainline televising, 5 of the 13 properties were identified with infiltration. Of the 5 properties identified with I/I in 2009, 3 participated in the program and 2 refused. The 2012 lateral televising did not identify any properties with I/I in this area. Two sags were identified, but do not appear to cause a flow problem. The three properties identified with I/I were again televised by the city in April, 2013 during a period of high groundwater and again observed with flow. The NPR CCTV crew did identify leakage on 2 of the properties around the lateral/manhole connection on April 30, 2013, even though groundwater was down.

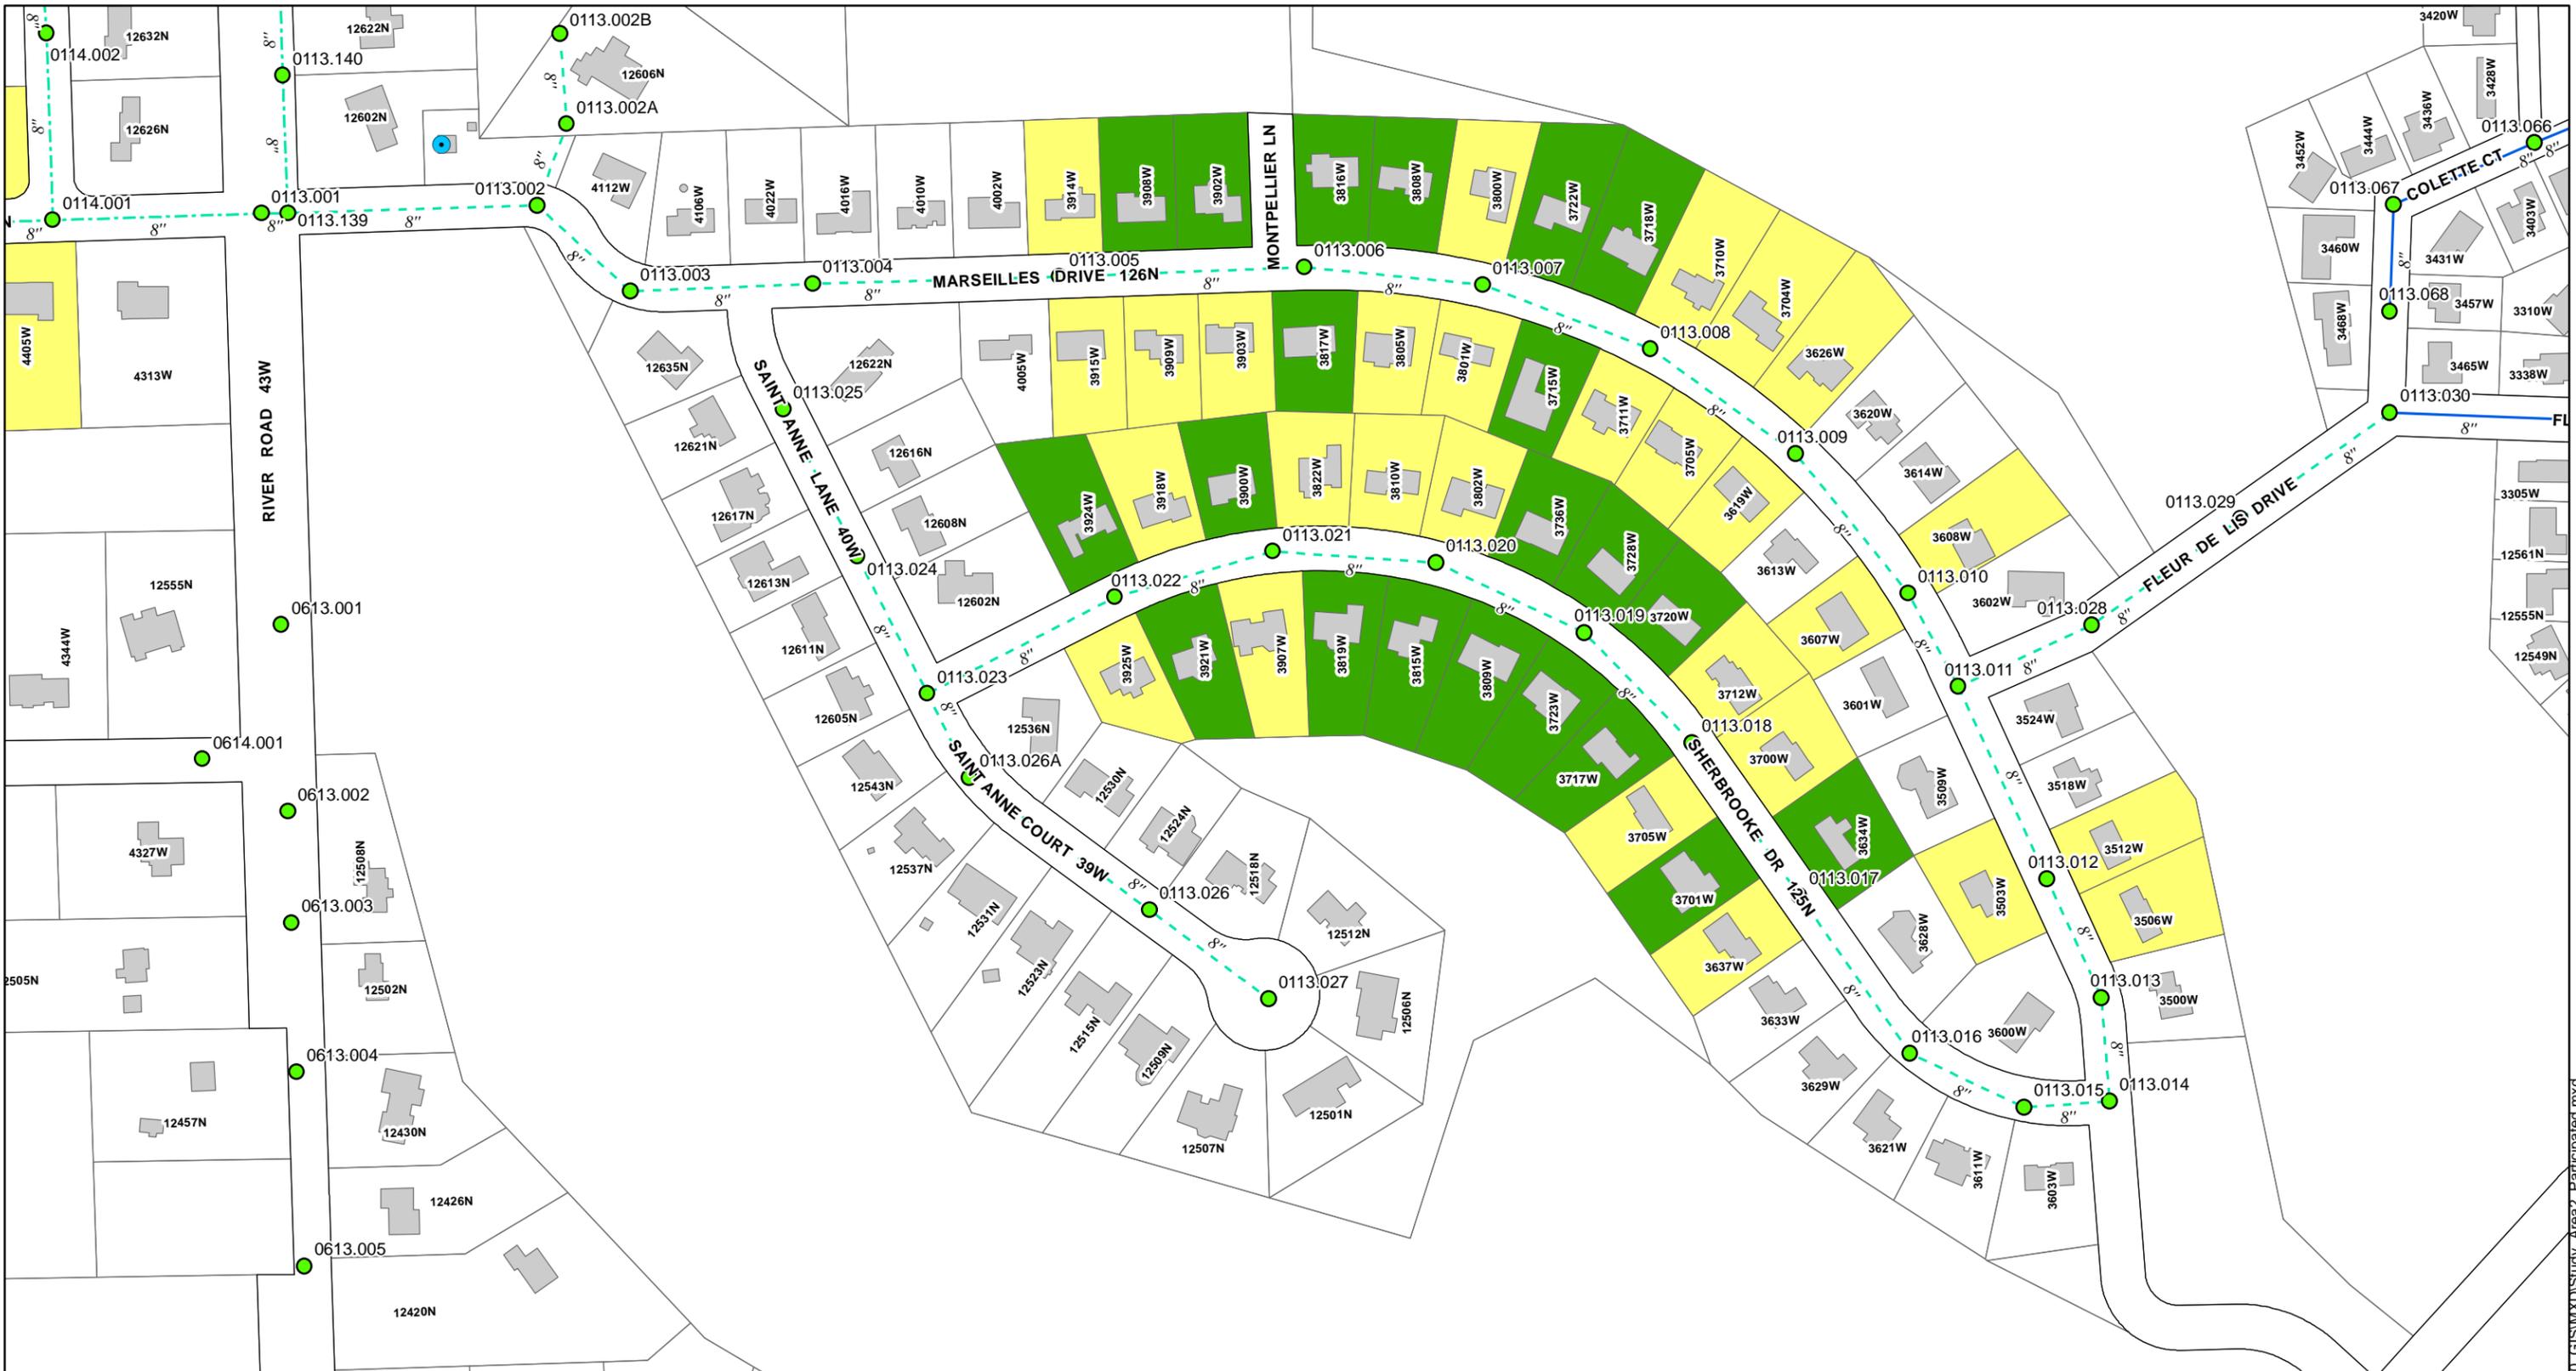
Study Area 2

Results: During the 2009 mainline televising, 10 of the 21 properties were identified with infiltration. Of the 10 properties identified with I/I in 2009, 3 participated in the program, 6 refused and 1 property did not respond. The 2012 lateral televising identified 1 property with broken pipe matching the identified I/I from the 2009 mainline televising. The broken pipe was not leaking during the lateral televising even though dye water was injected over the lateral. However, as this property showed significant flow in 2009 and 2013 it is assumed that the broken pipe was the source of the infiltration in 2009. The 2009 televising was completed during a wet period. In 2012, the year was very dry and most likely the surrounding ground absorbed the dye water injection. During April, 2013, the city again televised the mainline sewer during a period of high groundwater and identified 5 properties with running water in the lateral ranging from light to heavy clear water flow. NPR televised each of these laterals on April 30, 2013, but none were observed leaking. It appears that by the time that NPR was mobilized for the lateral launch CCTV, the groundwater had receded to an elevation lower than the invert of the laterals.

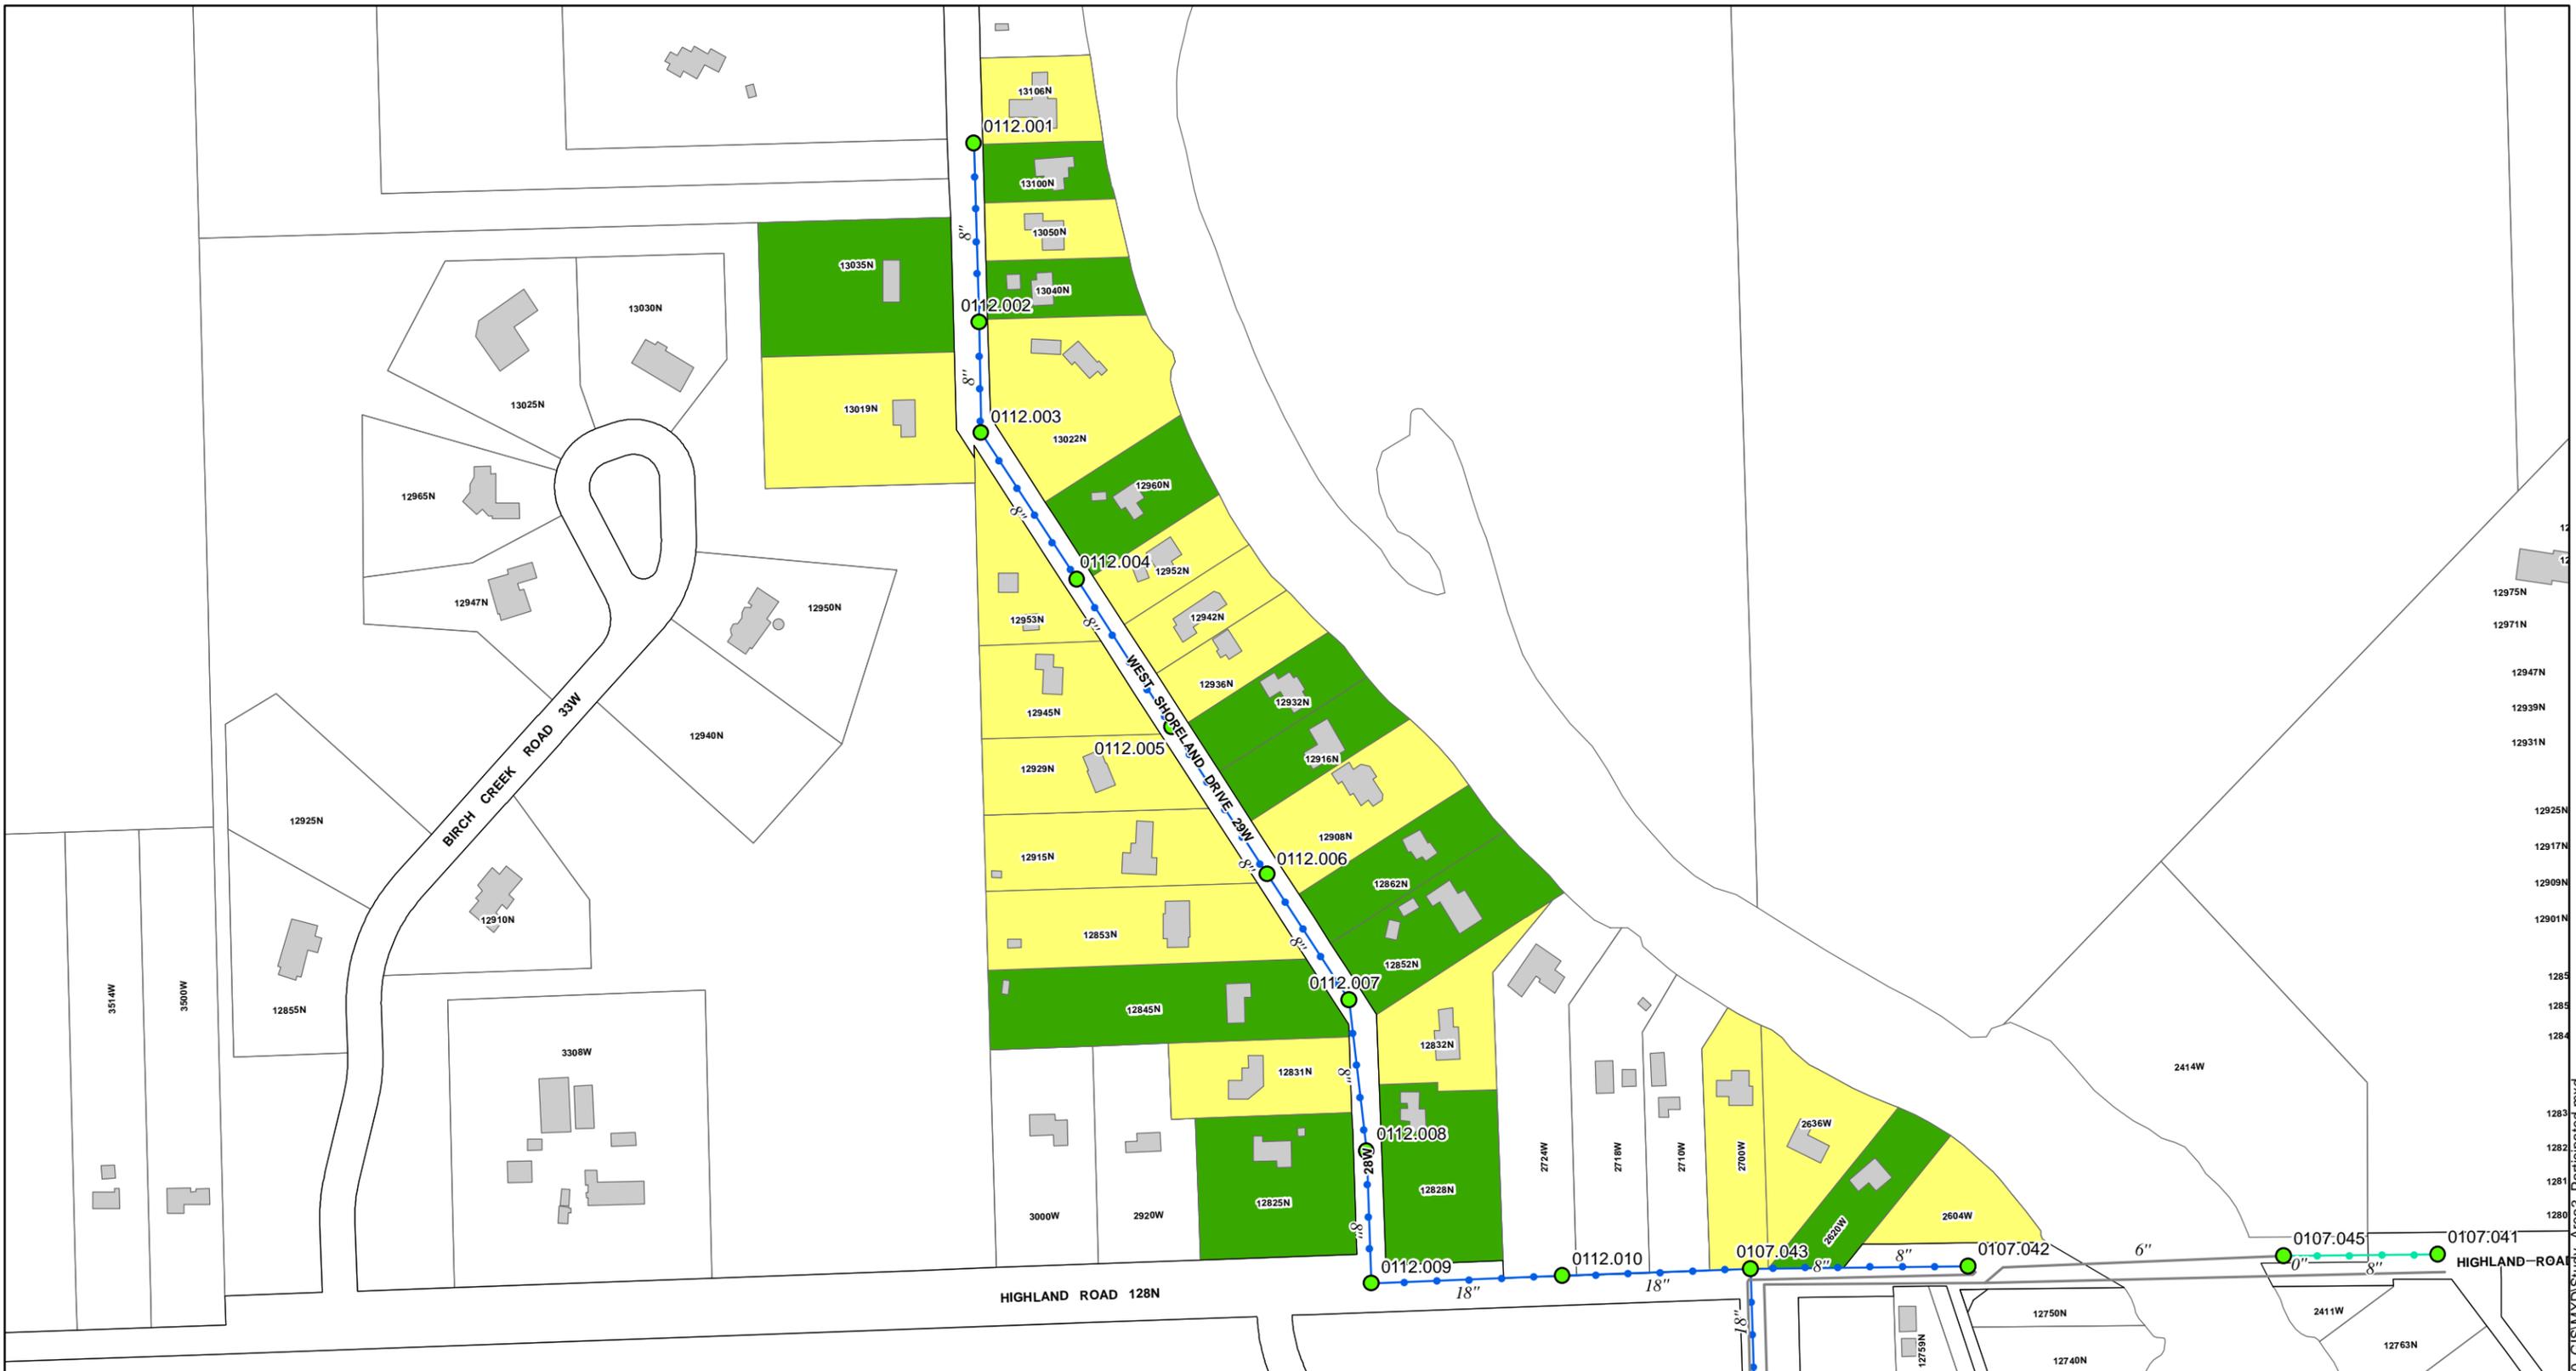
Study Area 3

Results: During the 2009 mainline televising, 20 of the 30 properties were identified with infiltration. Of the 20 properties identified with I/I in 2009, 9 participated in the program, 6 refused and 5 did not respond. 4 of the 9 properties that participated in the lateral televising were identified with leaks or potential leaks in the lateral. In addition, 2 of the properties were identified with roots, indicating a potential source of infiltration. The lateral at 12916 N West Shoreland Drive had a root plug 5 feet off of the mainline sewer and therefore, the lateral could not be televised beyond this point. The property at 12960 N West Shoreland Drive had wet deposits, but did not authorize the use of injections. The deposits indicate the previous occurrence of infiltration. Eight properties were identified with flow during the City's 2013 mainline televising as shown in Table 5. However, the lateral televising by NPR on April 30th did not identify I/I in three of the properties and so the additional lateral televising operation by NPR was shut down.
