# HAWTHORNE ROAD IMPROVEMENTS EVALUATION MEMO

**DATE:** 11/1/2019

**FROM:** Troy Hartjes, P.E., raSmith

**RE:** Hawthorne Road Improvements Evaluation and Gravel Road Analysis

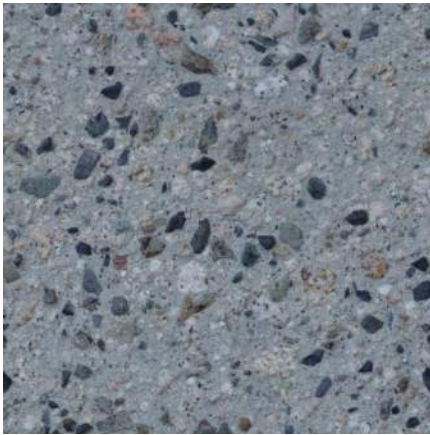
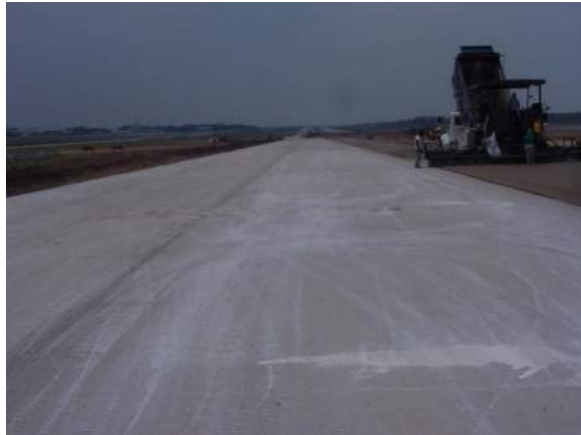
This option has minimal disturbance to the area adjacent to the roadway and involves adding a chemical stabilizer, as stated in geotechnical option D, to the top 12-inches of the existing gravel roadway. The stabilizer would bind the existing aggregate to form an impervious surface similar to concrete with a rustic gravelly look as shown below.

The chemically stabilized base can be surfaced with 2 to 4-inches of gravel or asphalt if desired. Since the chemically stabilized base has a rough surface the 2 to 4-inches of gravel surface stays in place due to friction. The impervious surface would help prevent water to infiltrate into the underlying gravel making it unlikely to rut and washout after rain events. If the drainage and the underling base course is not improved as part of this alternative then soft spots will still exist in wet weather conditions and in time cracks will likely form. Once cracking starts, the impervious surface will erode quickly due to freeze/thaw conditions. The Qualitative Evaluation Factors are shown below:

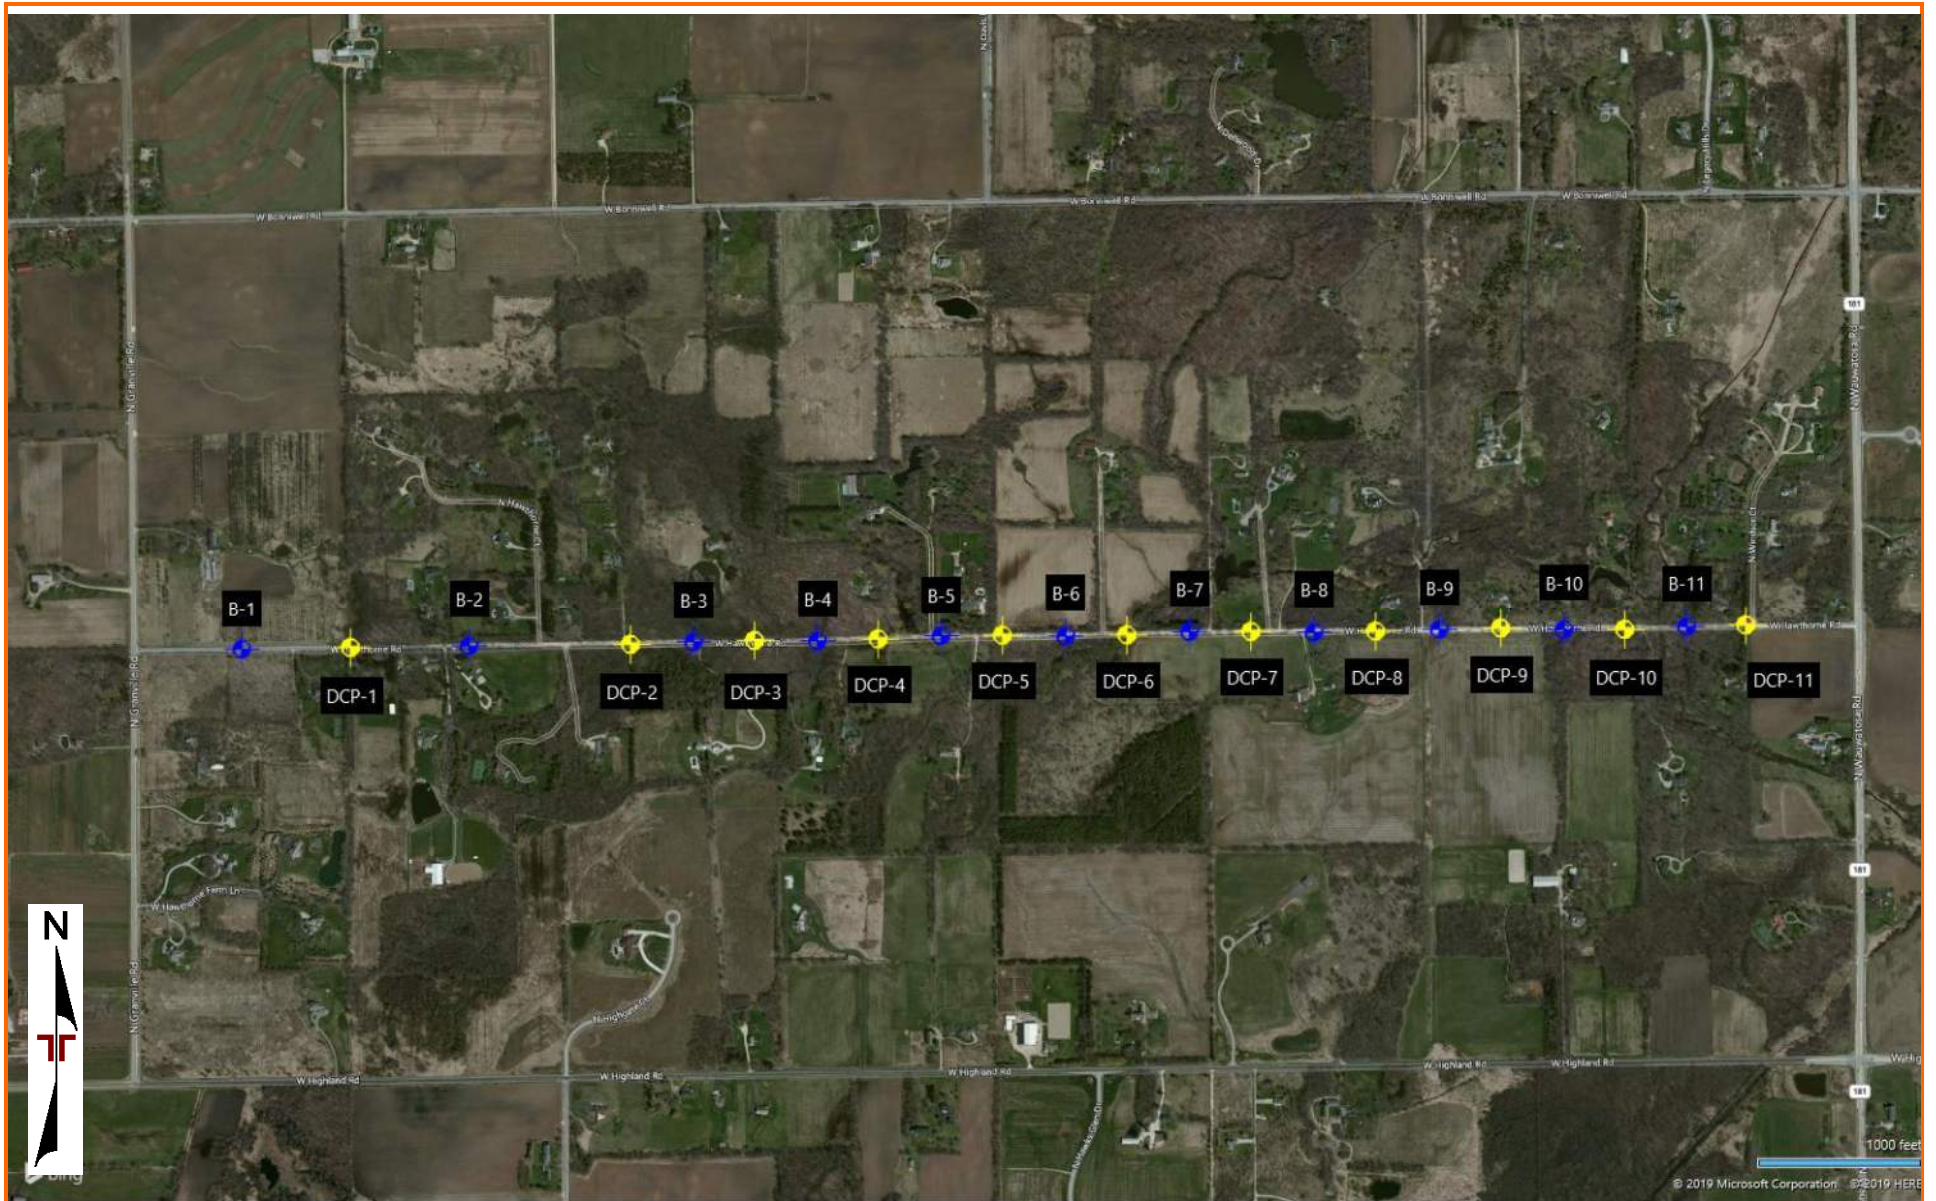
## EXPLORATION PLAN

Pavement Exploration-Hawthorne Road ■ City of Mequon, WI October 31, 2019 ■ Terracon Project No. 58195078 Rev 1

Subsurface conditions at each boring location are described on the individual boring logs in Appendix A. The stratification boundaries shown on the boring logs represent the approximate depths where changes in material types occur. In-situ, transitions between material types can be more gradual. Based on the results of the borings, the pavement section thicknesses are summarized in the table below:

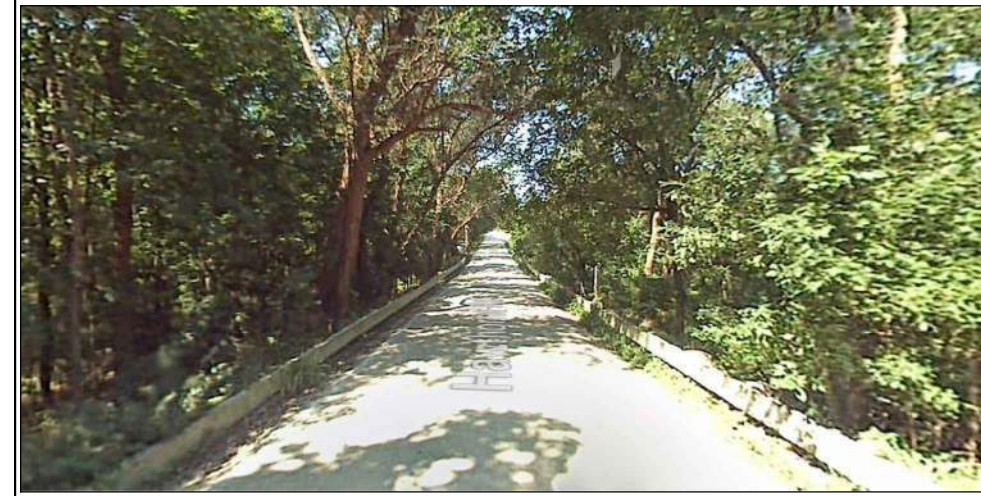
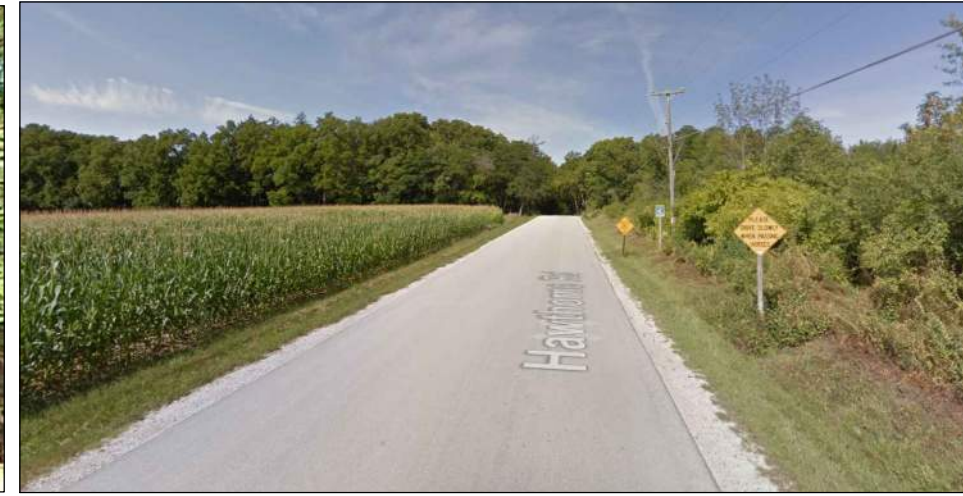
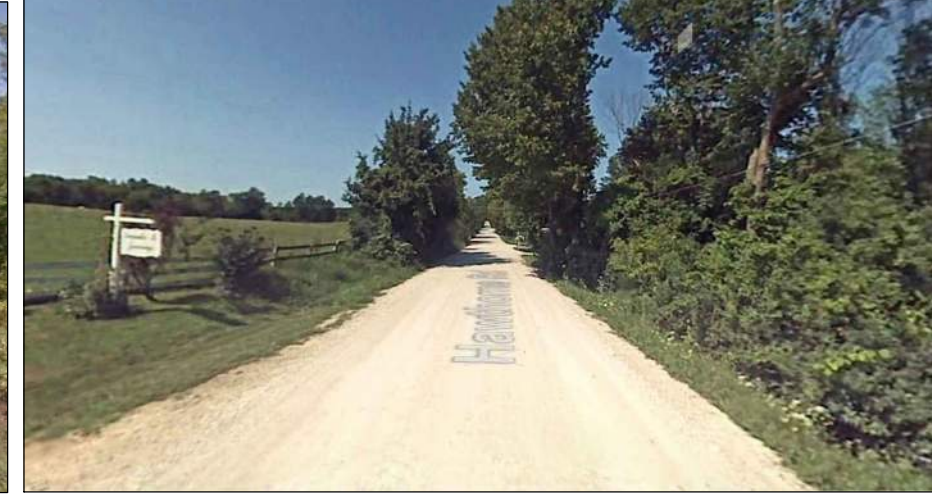
CITY OF MEQUON  
 OZAUKEE COUNTY, WISCONSIN  
 HAWTHORNE ROAD EXHIBIT  
 OPTION 1 - MAINTAIN EXISTING GRAVEL

#### OPTION 1 SUMMARY:

1. EXISTING GRAVEL TO REMAIN. THE ROAD WIDTH AND LAYOUT WILL NOT CHANGE.
2. MAINTENANCE REQUIRED AFTER RAIN EVENTS TO MAINTAIN QUALITY OF RIDE.
3. THE SURROUNDING TREES WILL NOT BE IMPACTED UNLESS THE DRAINAGE IMPROVEMENT OPTION IS PERFORMED.

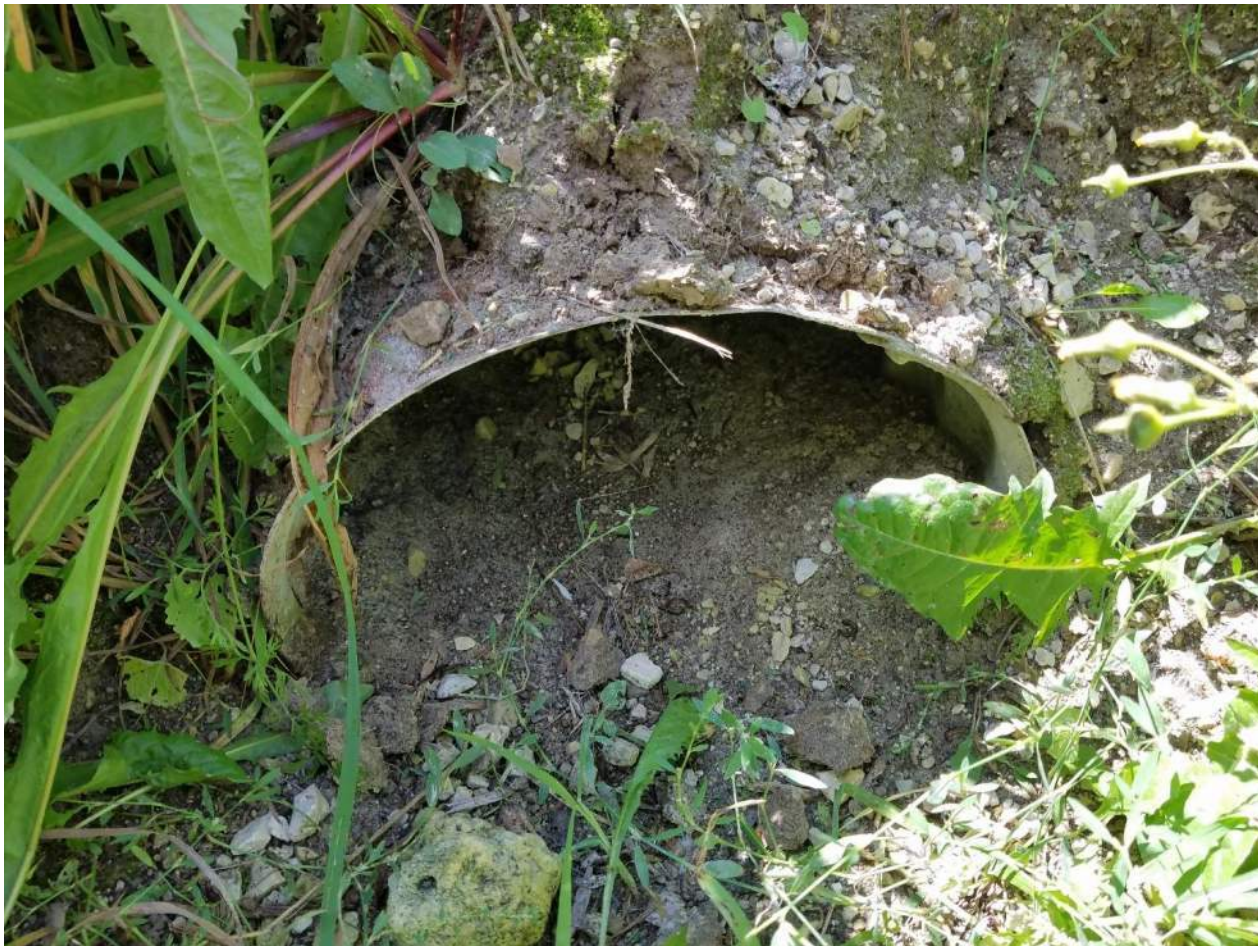
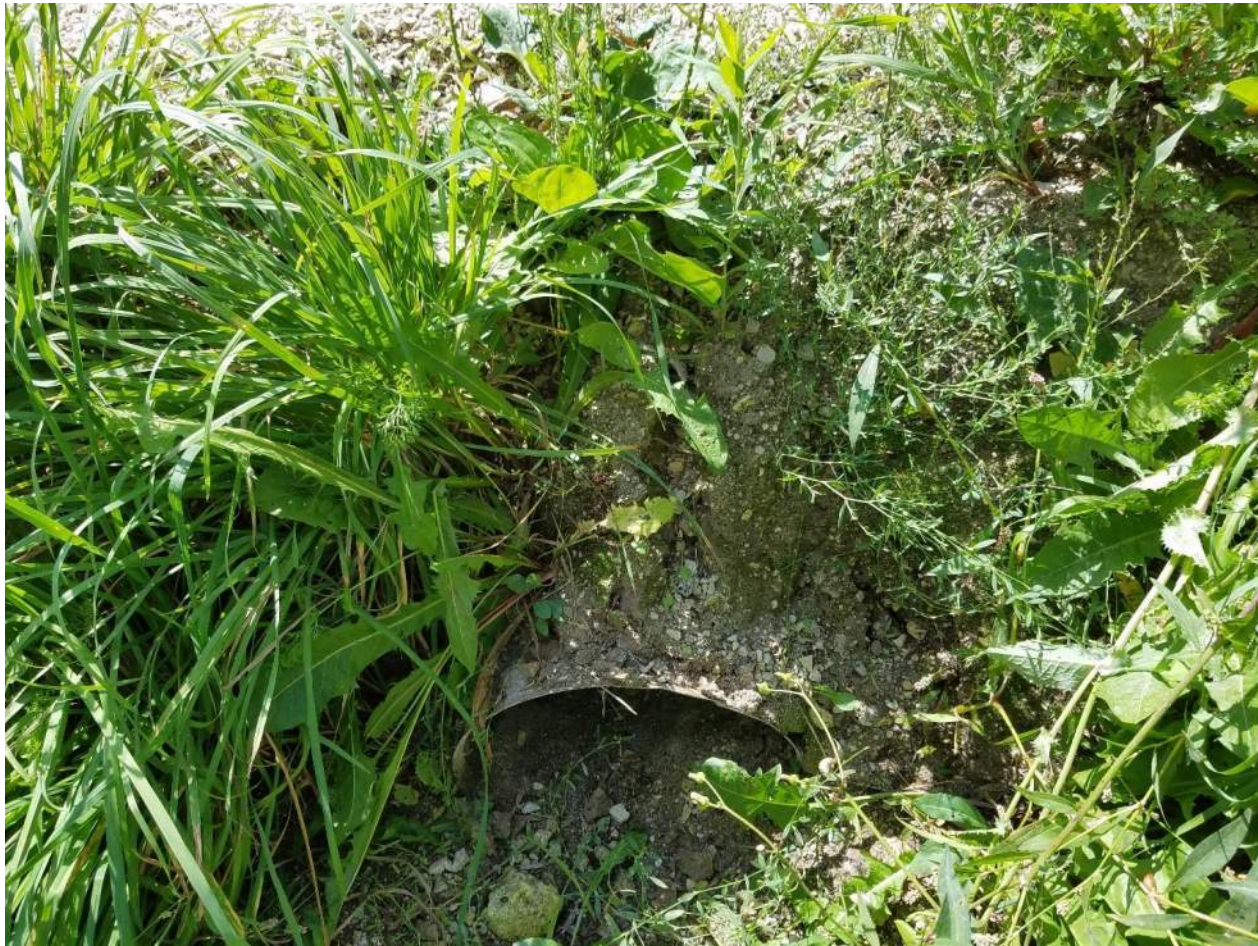
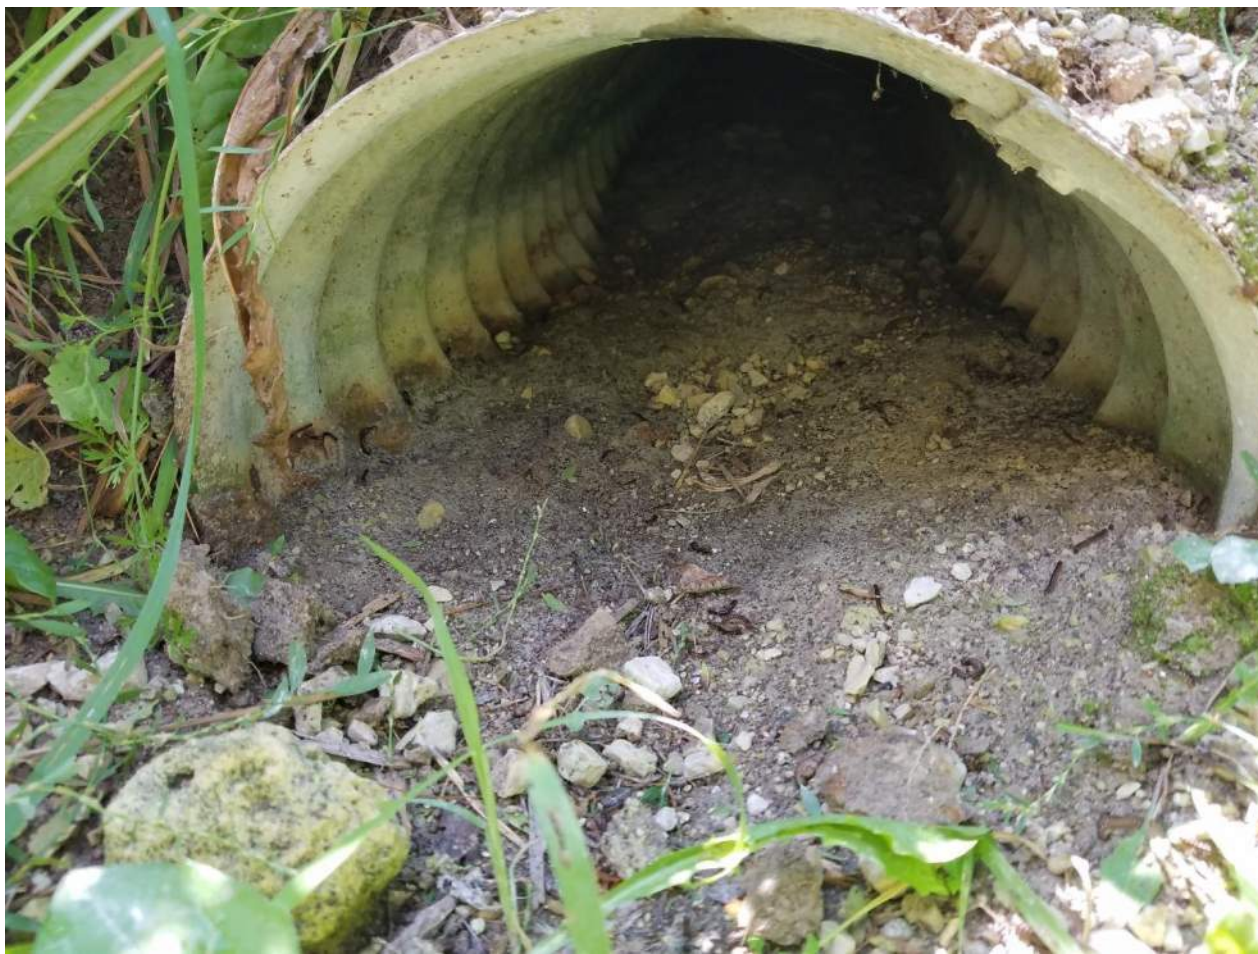
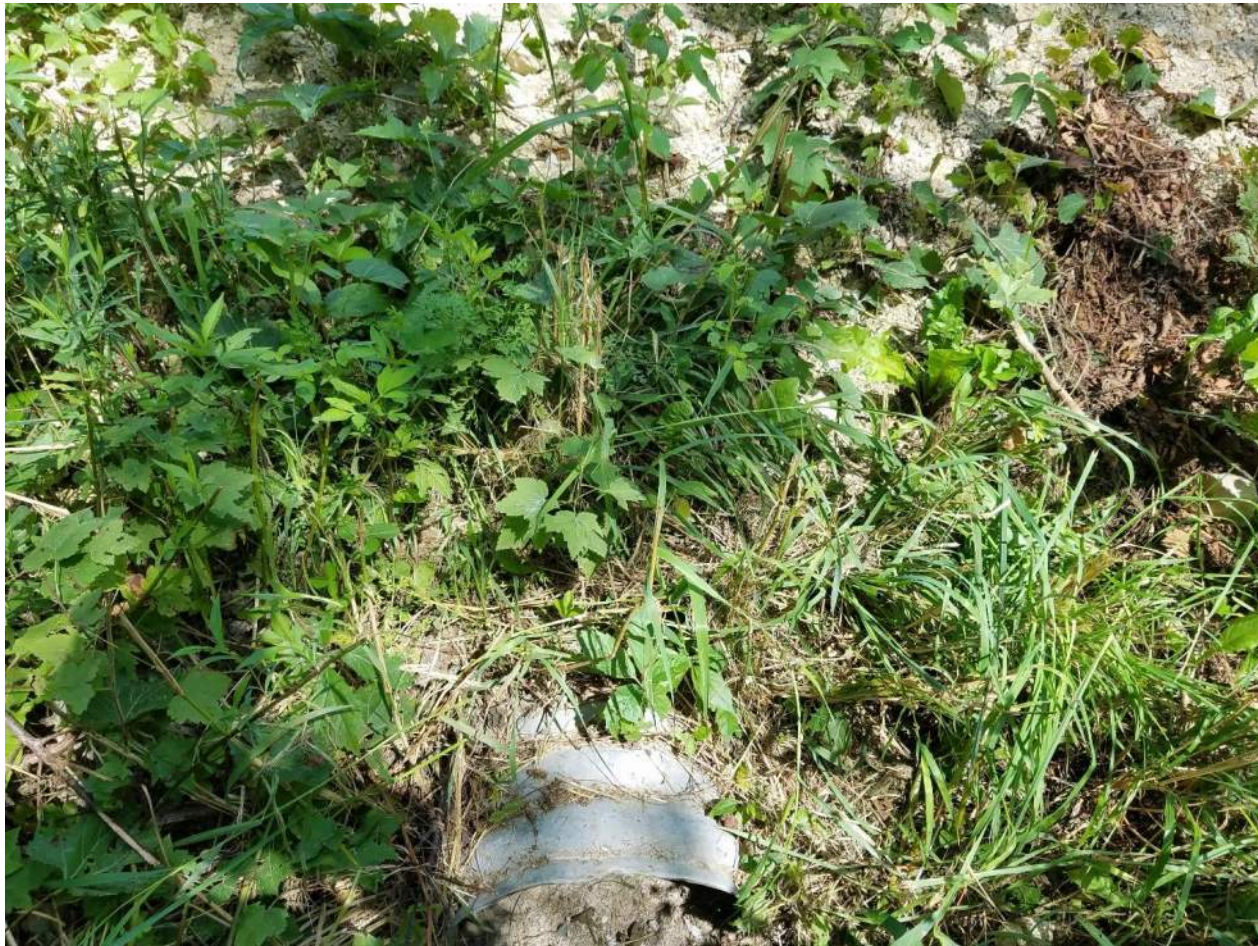
Pipe is in poor condition with bottom most likely rusted out. Pipe is half full of sediment. Flow is restricted due to sediment and water may back-up along roadway creating saturated roadway base conditions leading to soft spots and rutting in roadway. Recommended to clean out sediment or replace pipe.

Pipe Condition Pipe is in poor condition. Bottom  
may be rusted-out. Pipe is half  
full of sediment.

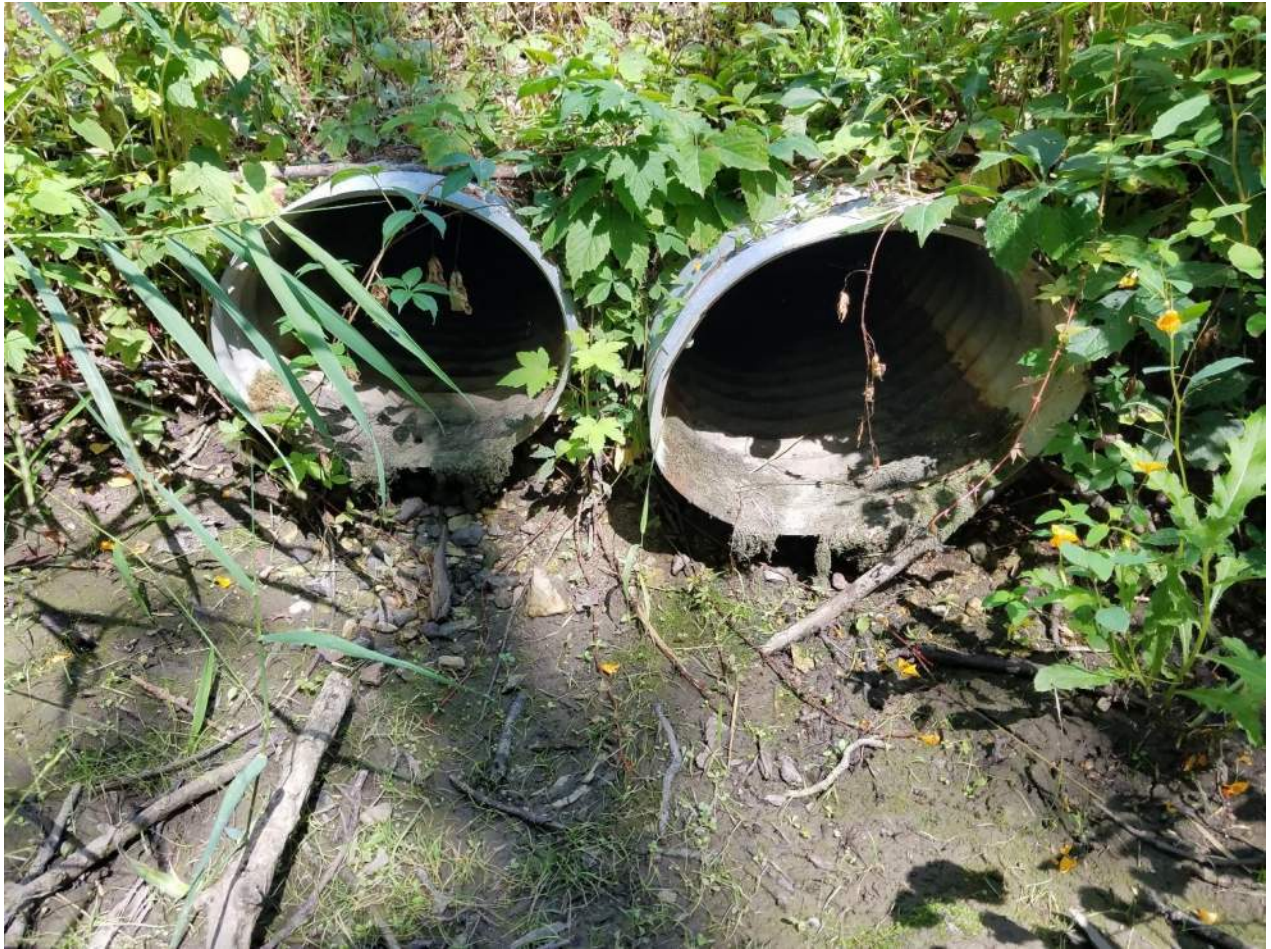
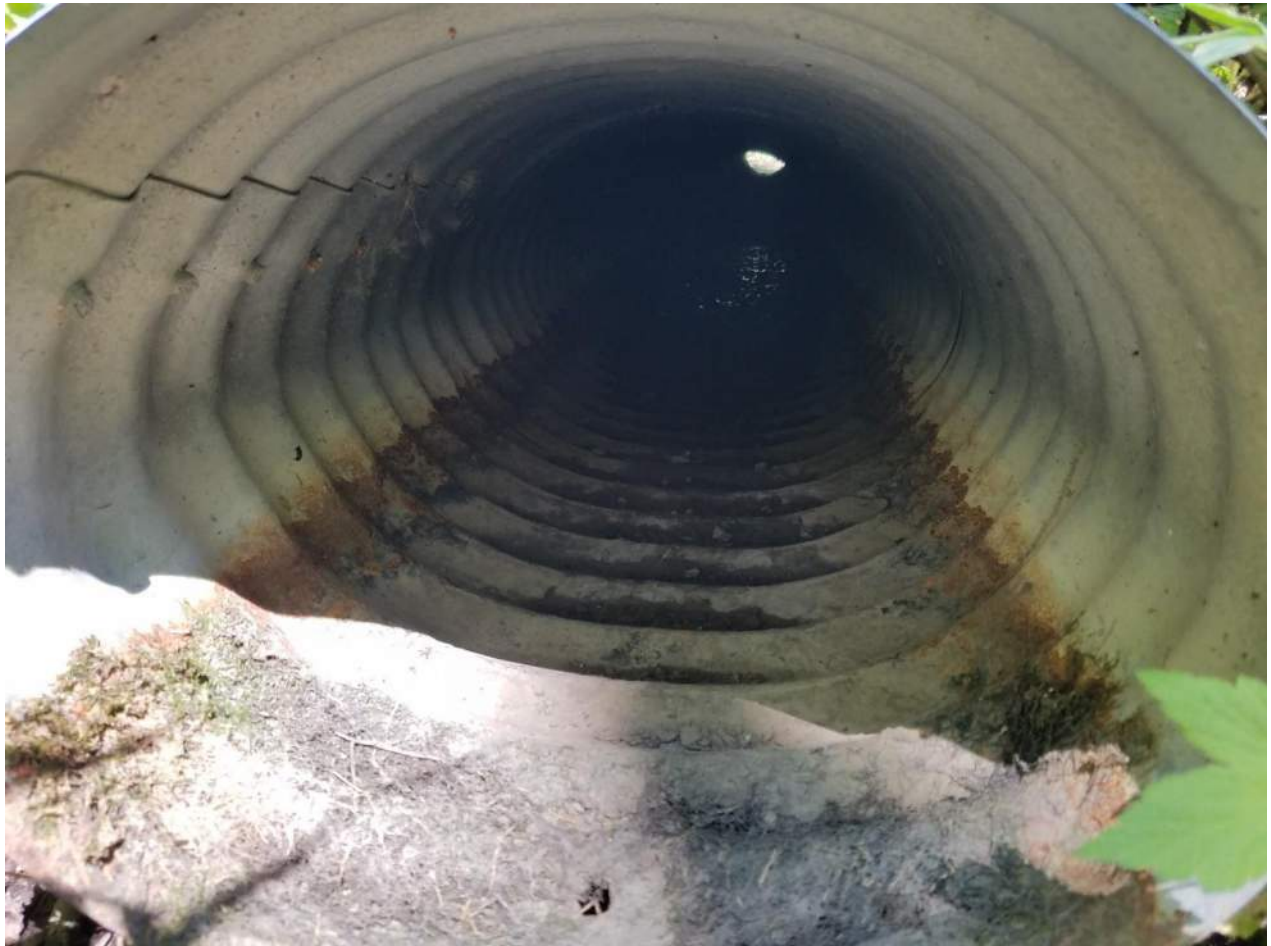
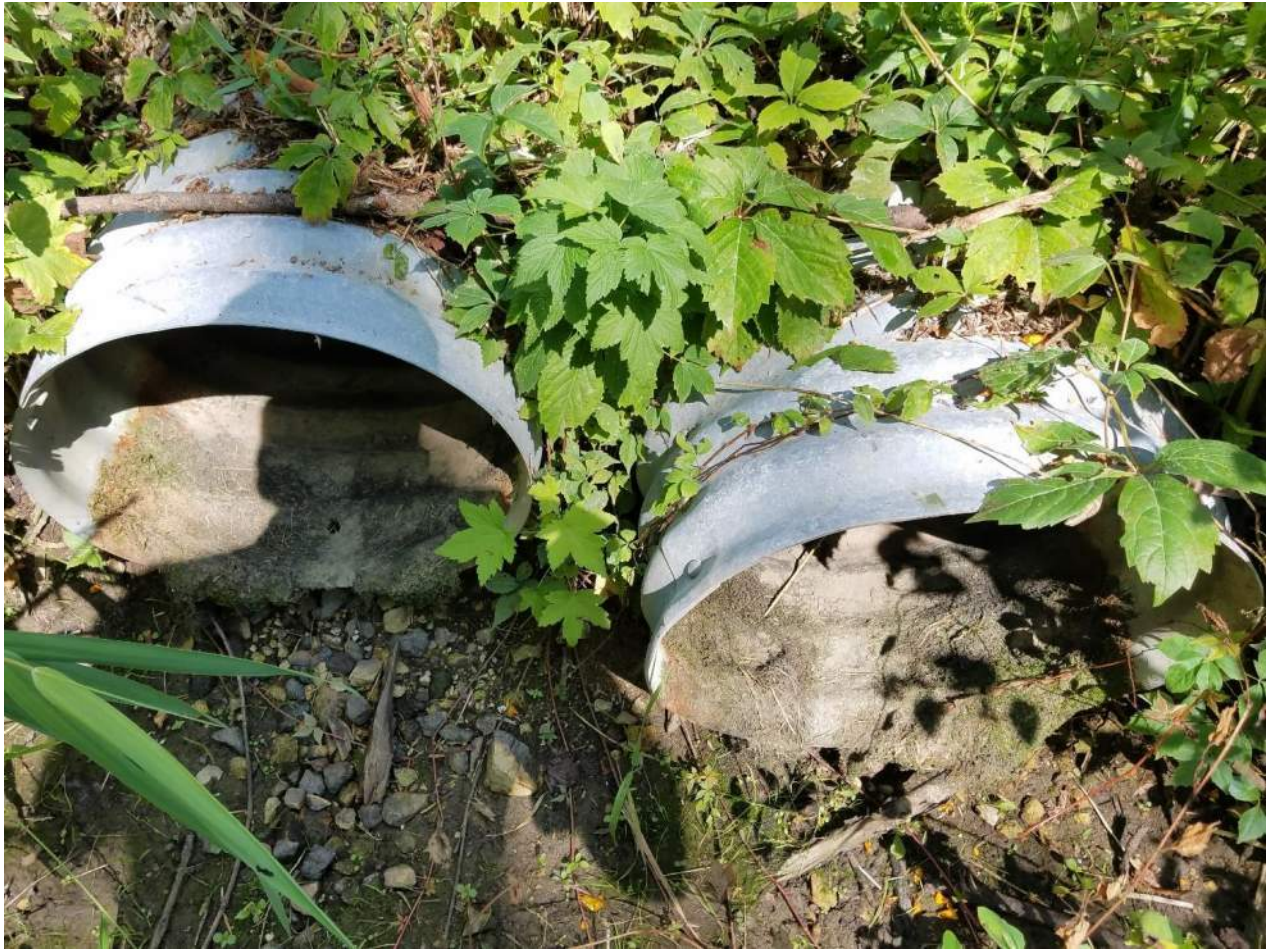
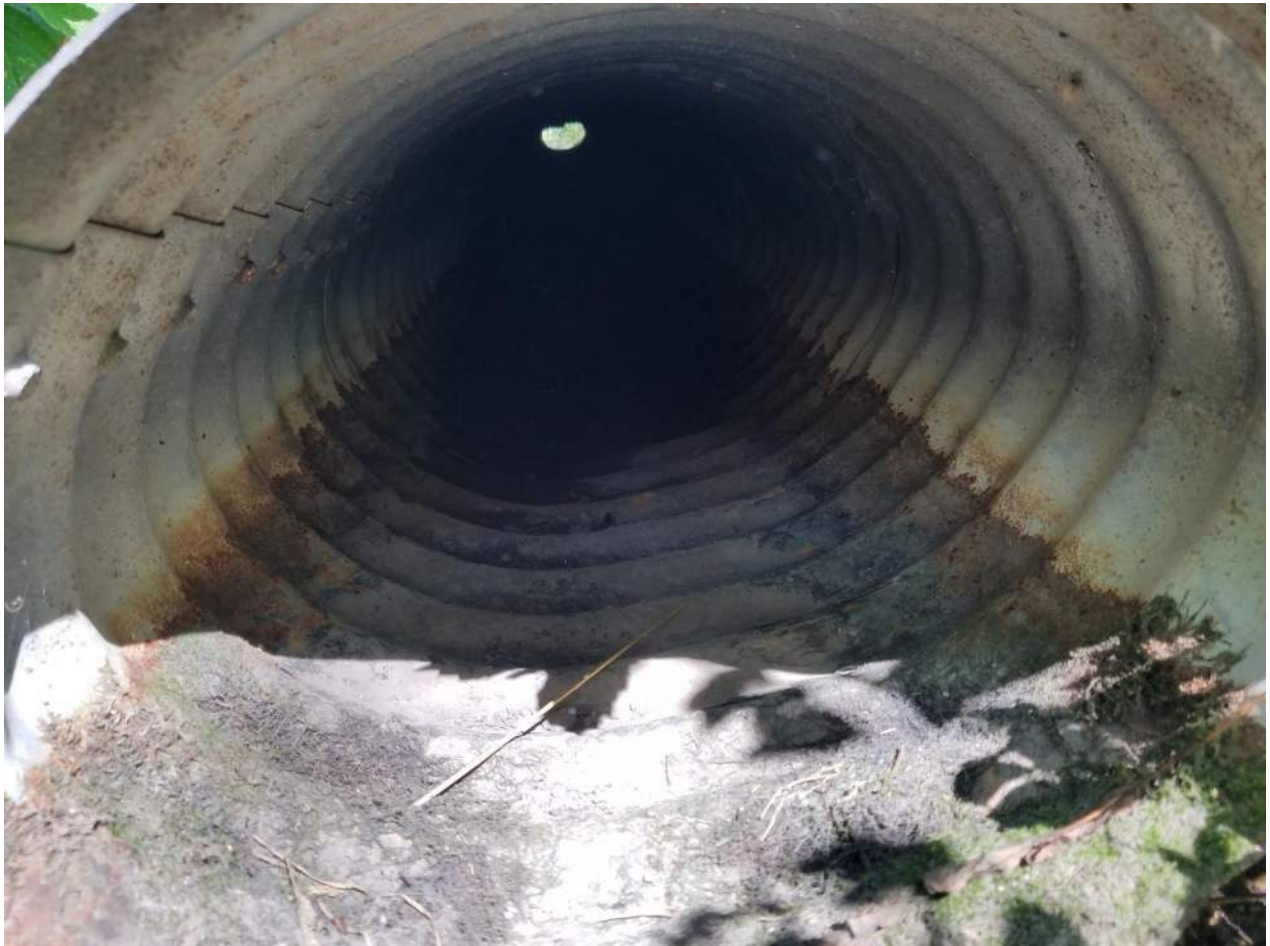
Pipe is in fair condition with a rusty bottom. Pipe is fairly clean with small amount of sediment. Recommended to clean out sediment or replace pipe. Culverts are raised 2 to 3-inches above the surrounding ground creating a chance for water to infiltrate the ground under the road base. Recommend lowering the culverts to be flush with the ground.

Pipe Condition Pipes are in fair condition with a rusty bottom. Not much sediment in bottom of pipes. Culverts are raised above ground 3-inches.

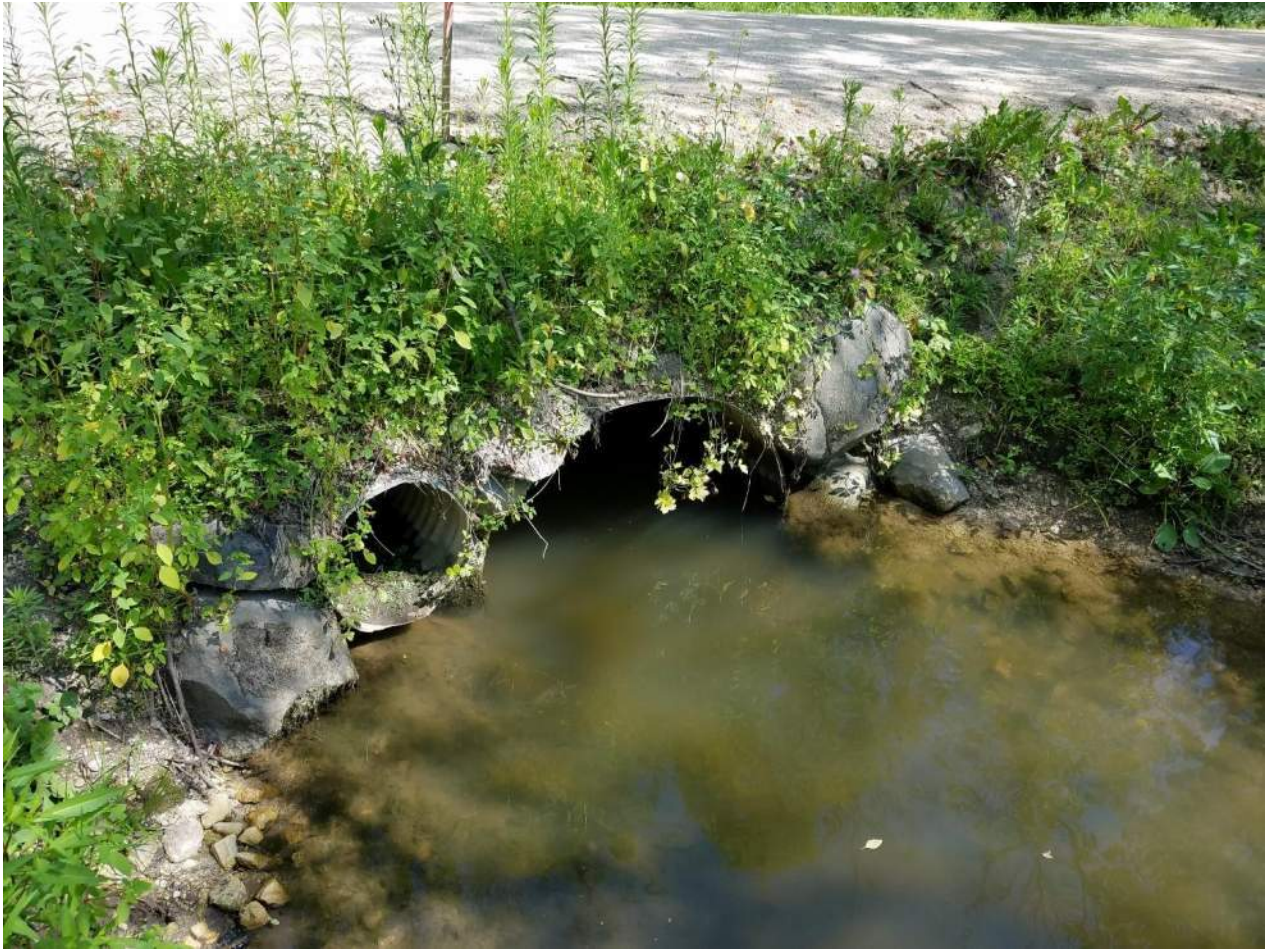
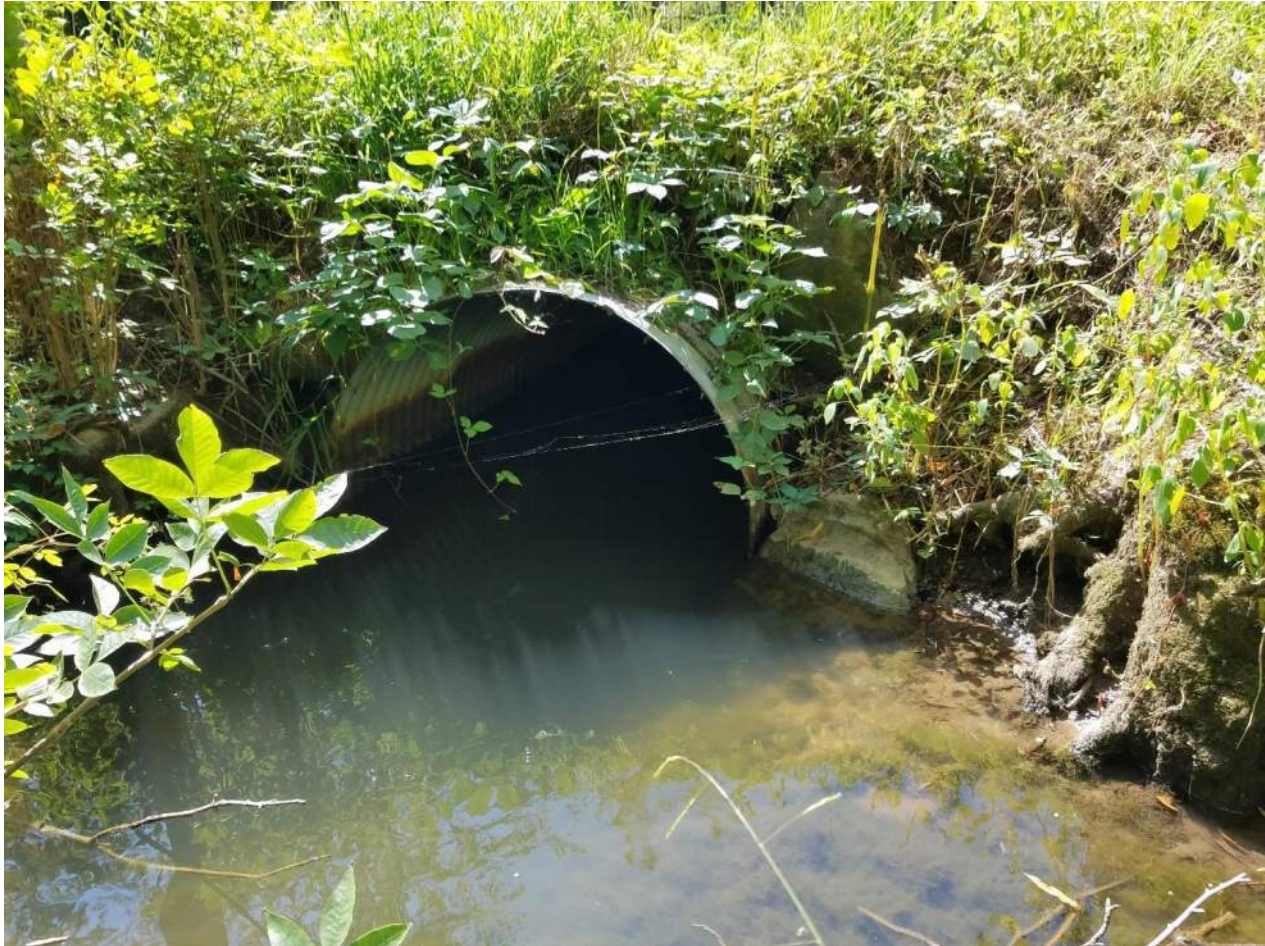
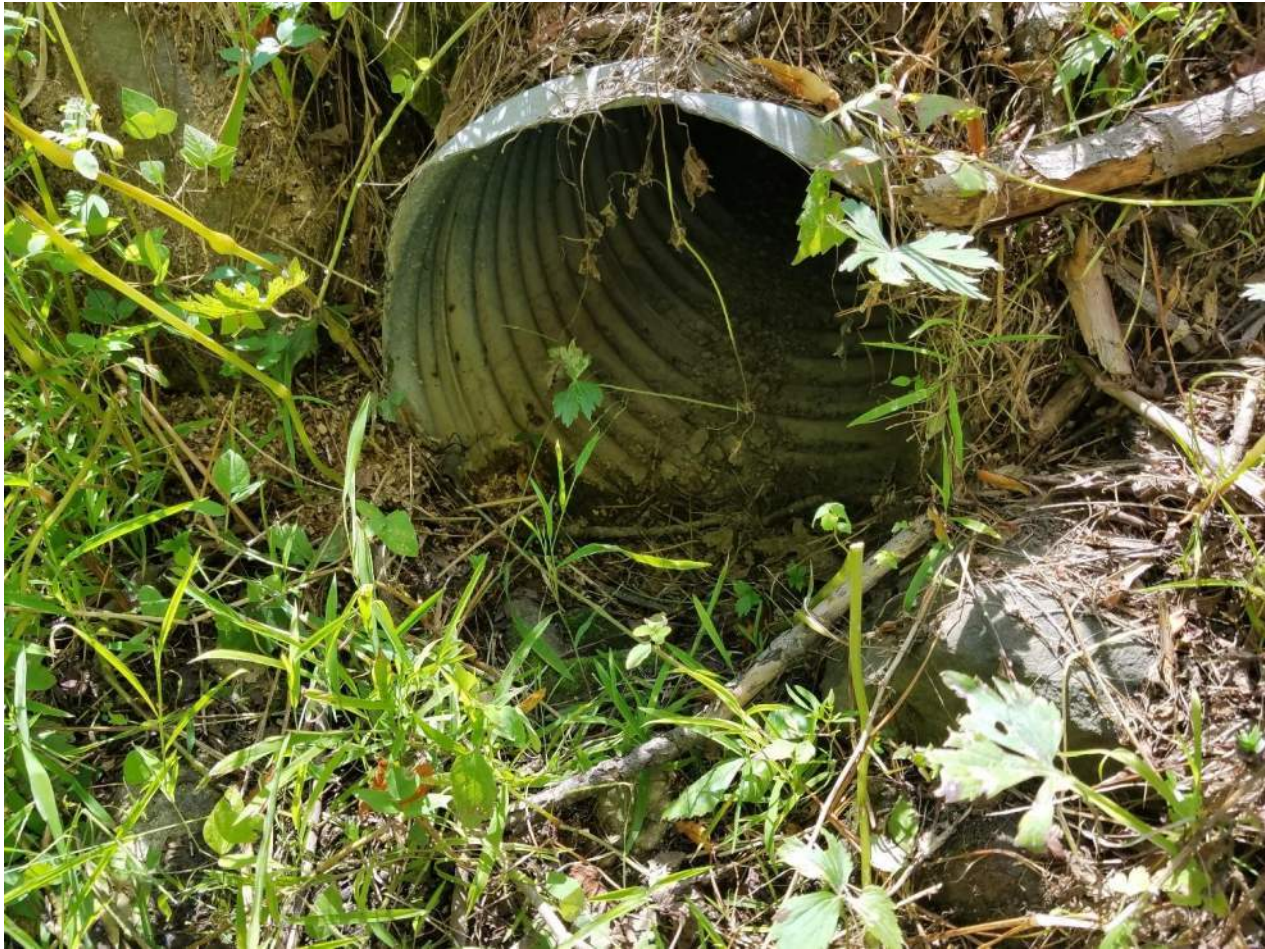
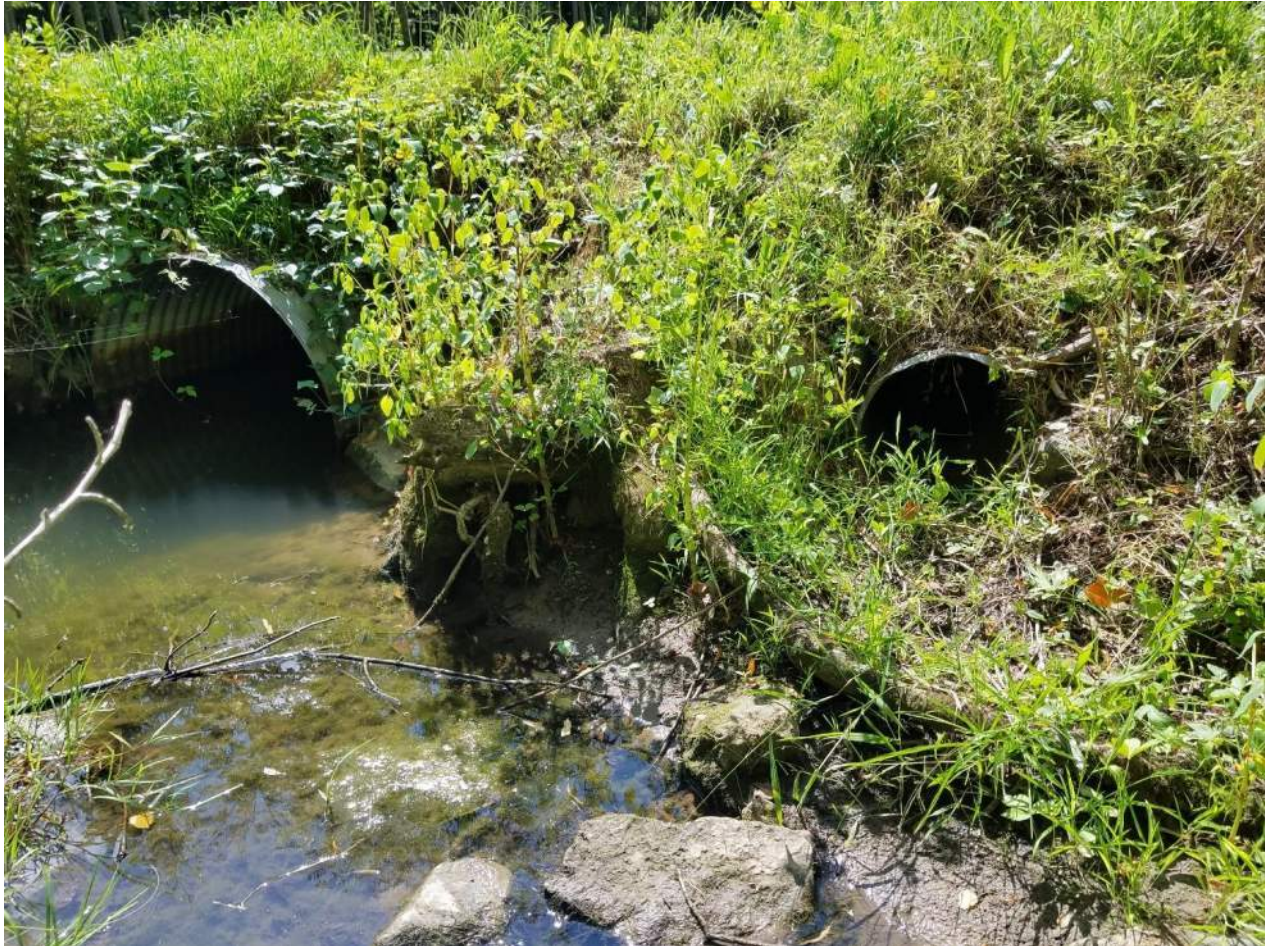
Both pipes are in fair condition. The 48" CMP is half submerged in water and the 15" CMP invert elevation is 2.3' above the 48" invert elevation. There is some sediment in the 15" CMP. Recommend cleaning sediment out of 15" CMP and lowering pipe invert to surface water elevation.

Pipe Condition Pipes are in fair condition. The 48"  
CMP is half submerged and the 15"  
invert elevation is 2.3' above the  
48" invert elevation. There is some  
sediment in the 15" CMP.

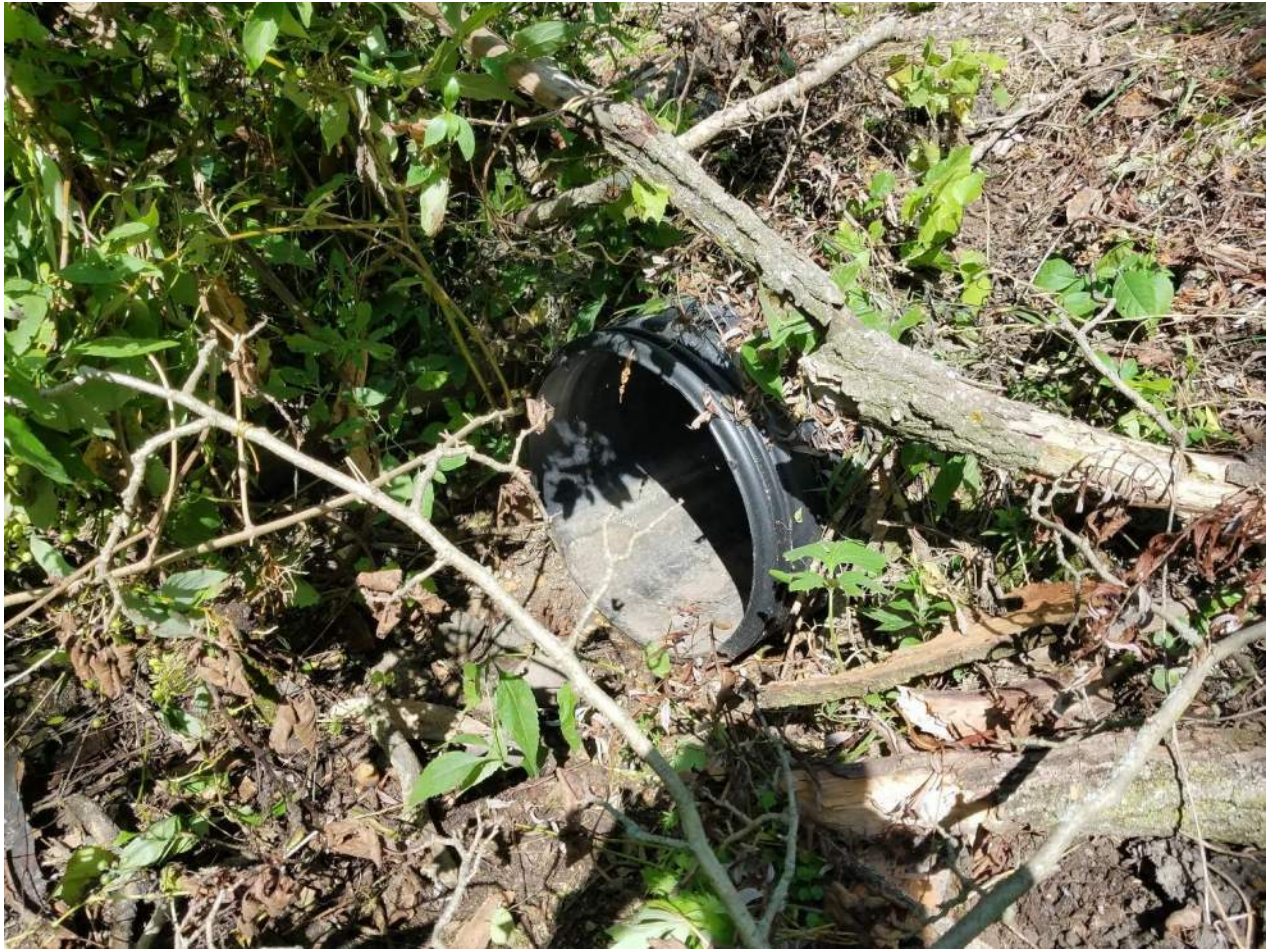
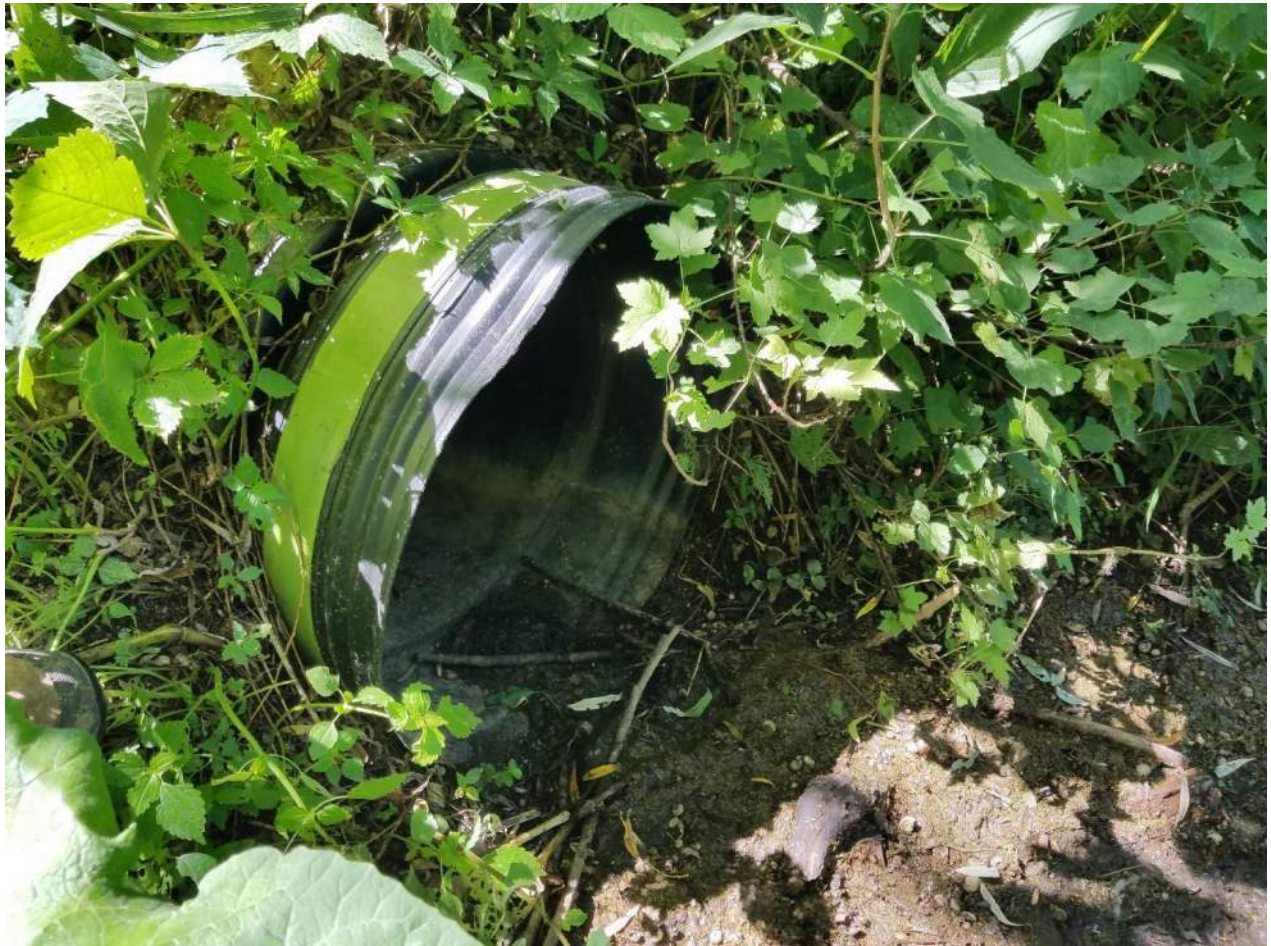
Pipe is in good condition with no maintenance required.

Pipe Condition Pipe condition is good.  
Pipe is clean with no debris or  
sediment.
