# HAWTHORNE ROAD IMPROVEMENTS EVALUATION MEMO

**DATE:** 11/1/2019

**FROM:** Troy Hartjes, P.E., raSmith

**RE:** Hawthorne Road Improvements Evaluation and Gravel Road Analysis

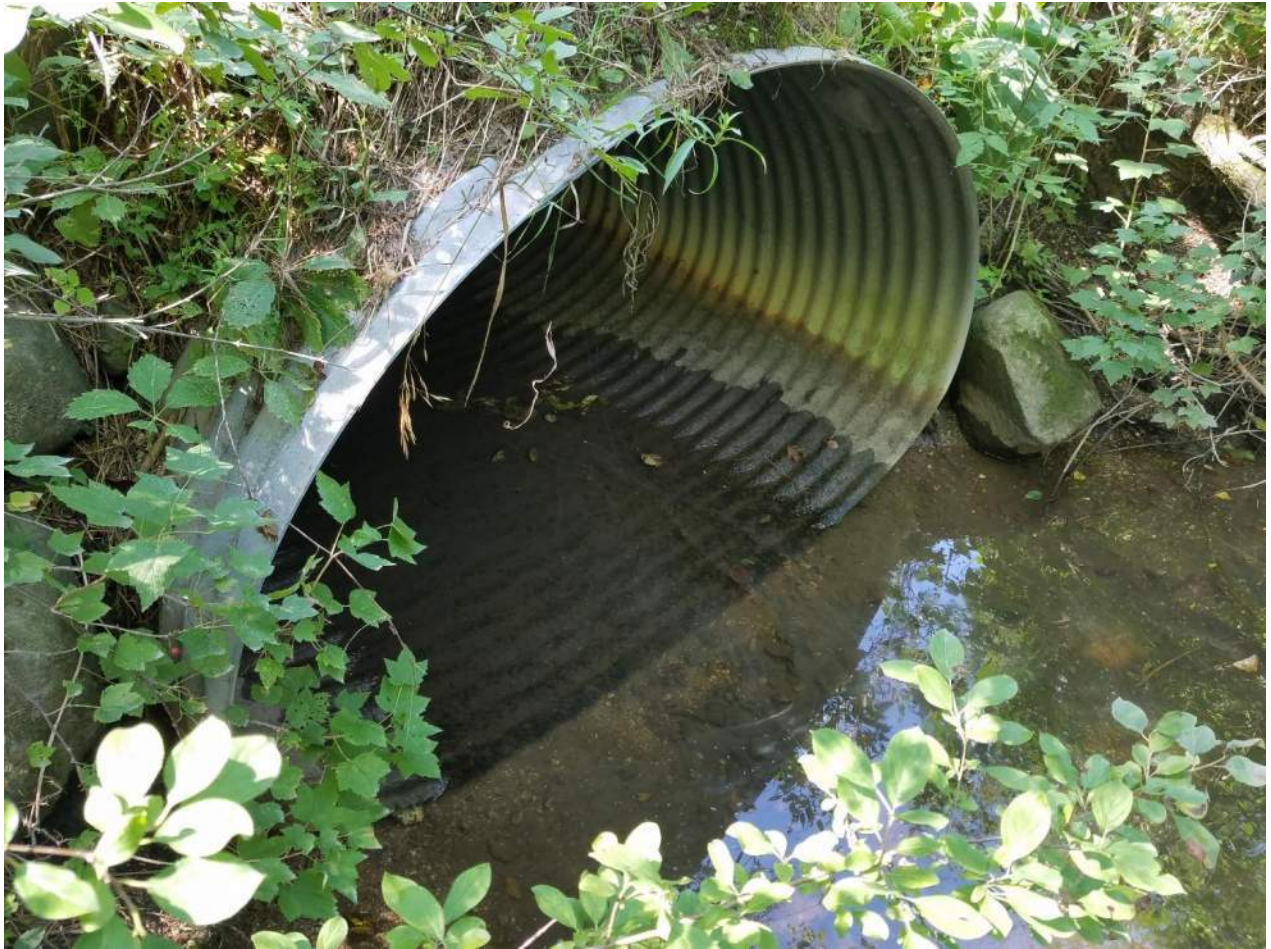
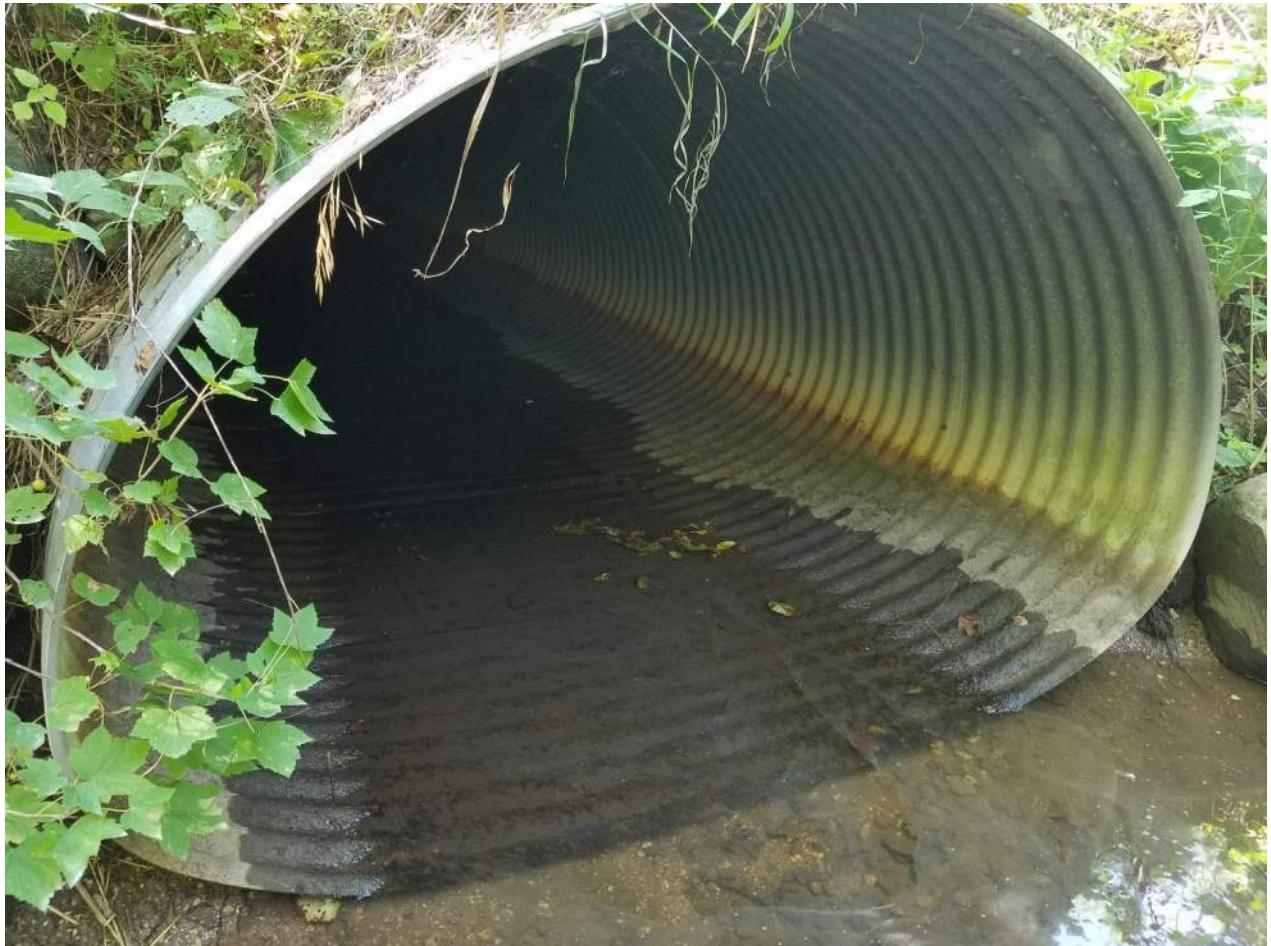
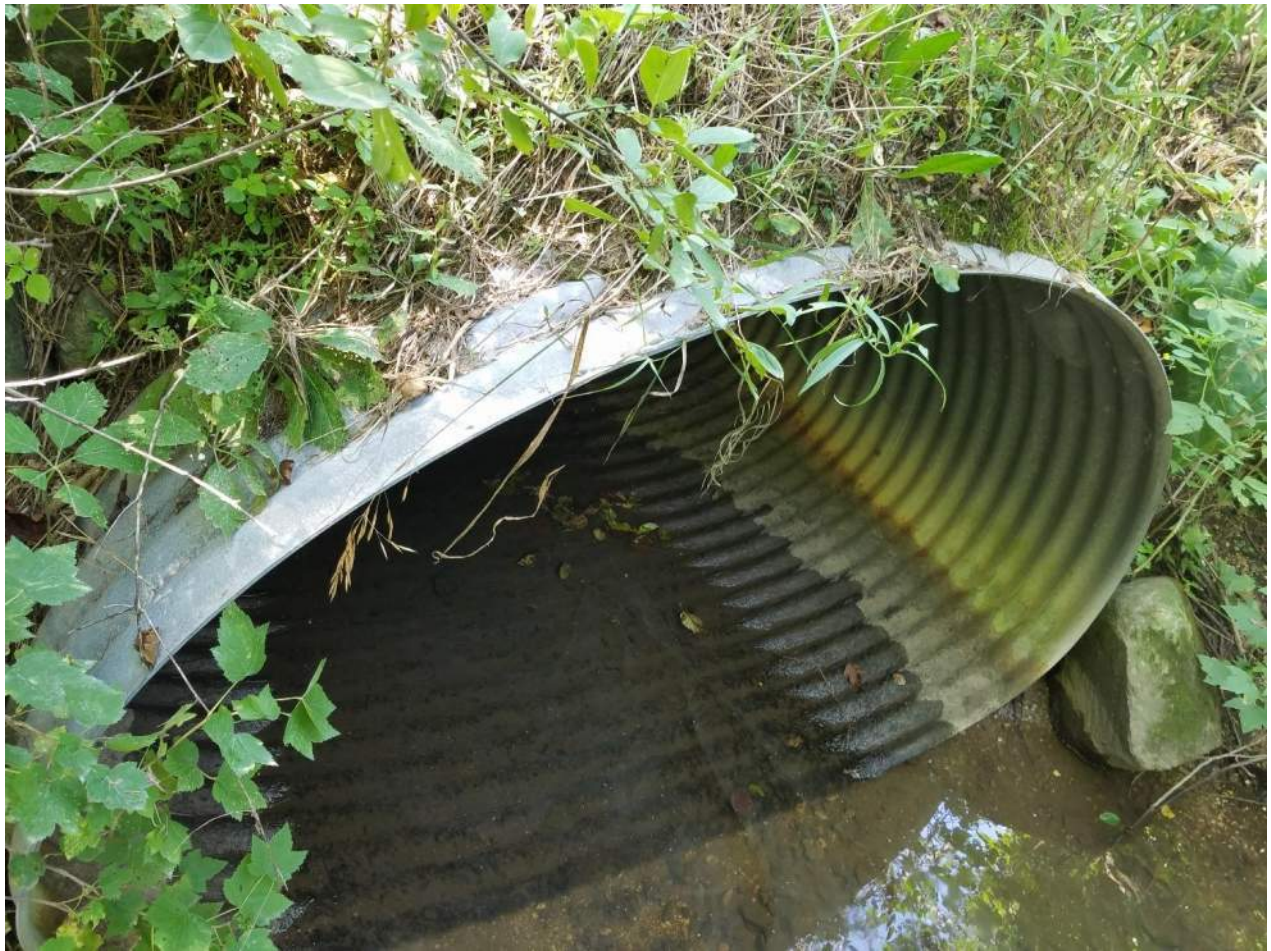
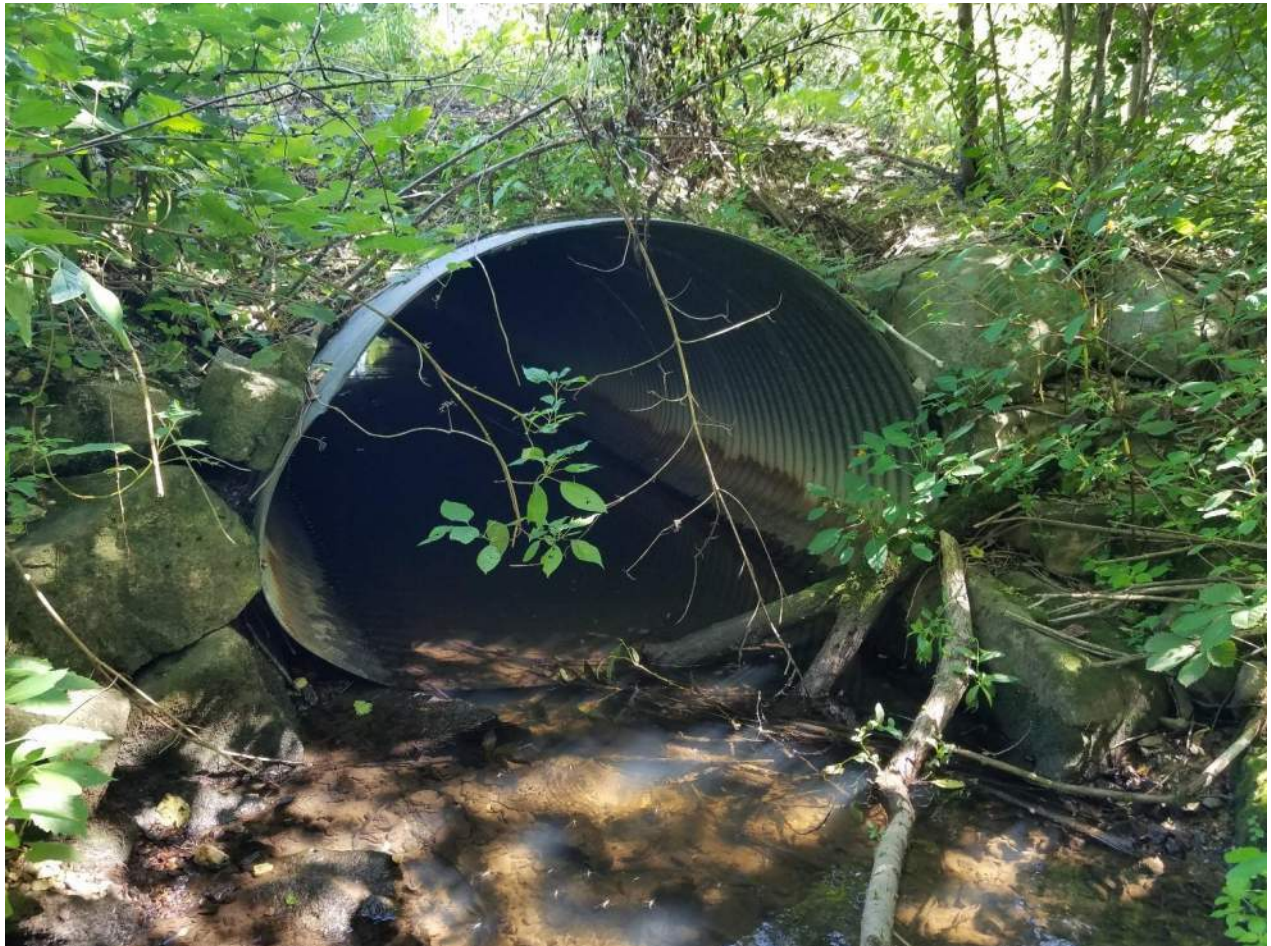
Pipe is in good condition. Recommend remove branches from end of culvert that may be inhibiting flow.

Pipe Condition Pipe is in good condition.  
\_\_\_\_\_  
\_\_\_\_\_

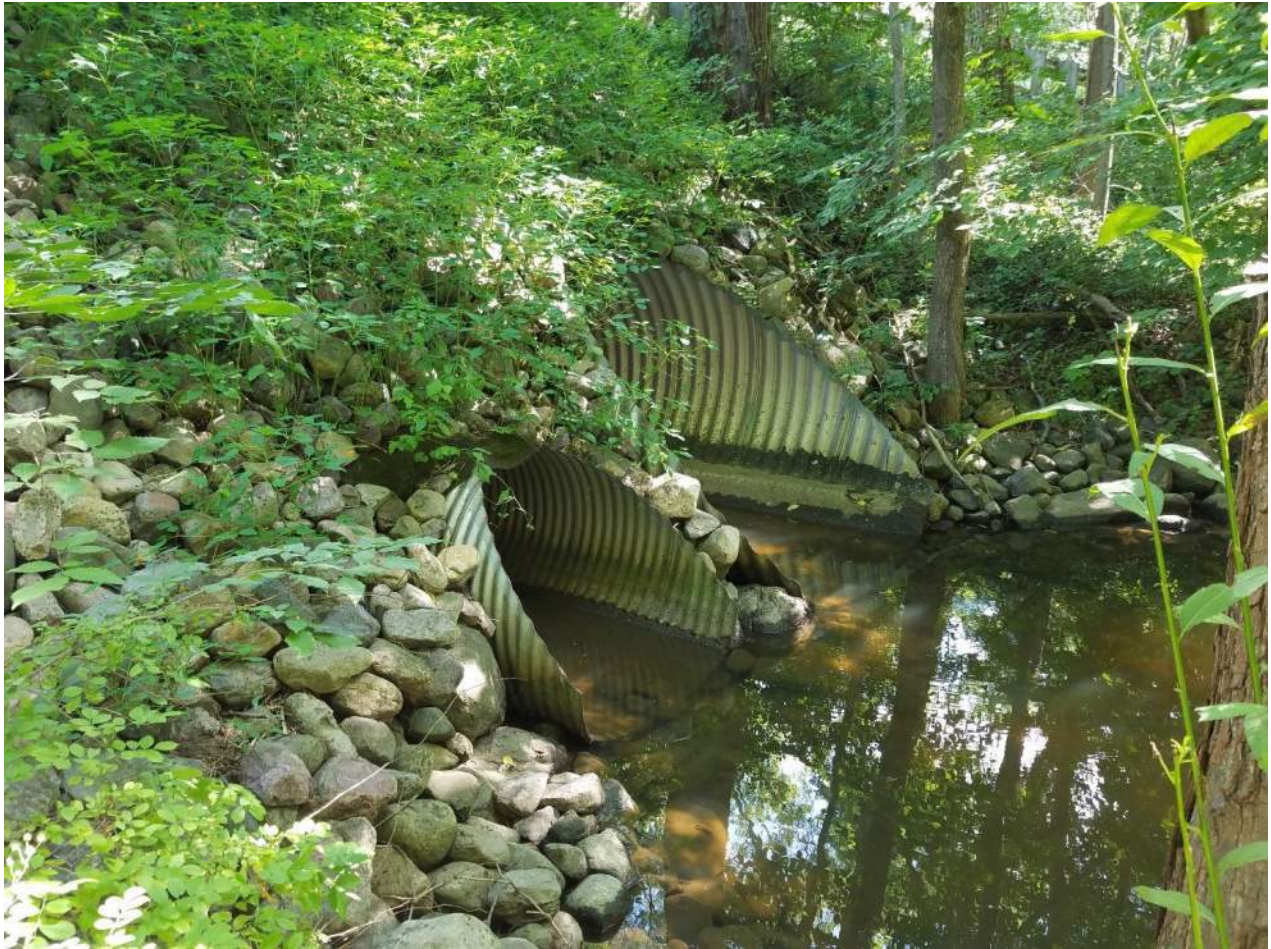
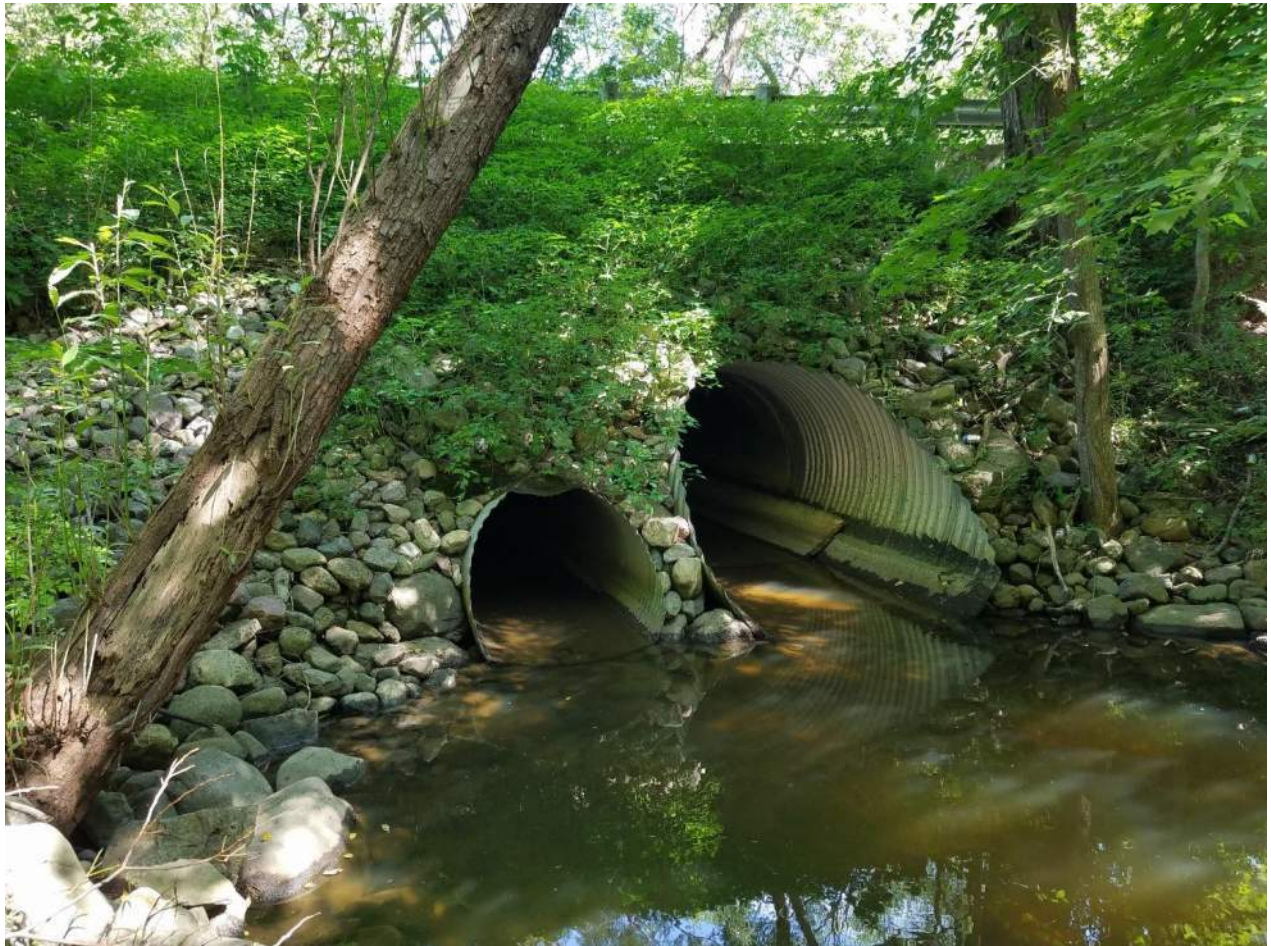
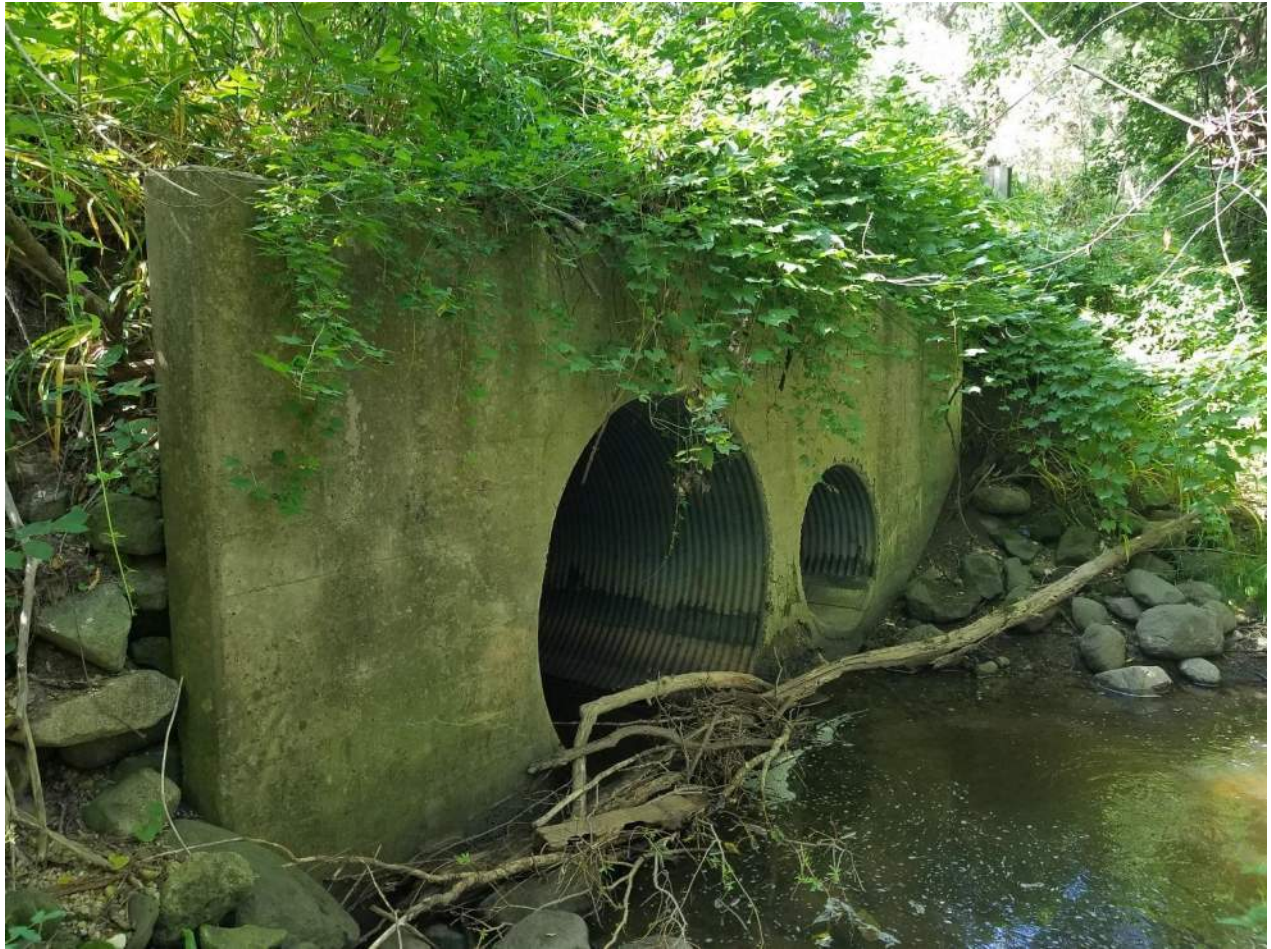
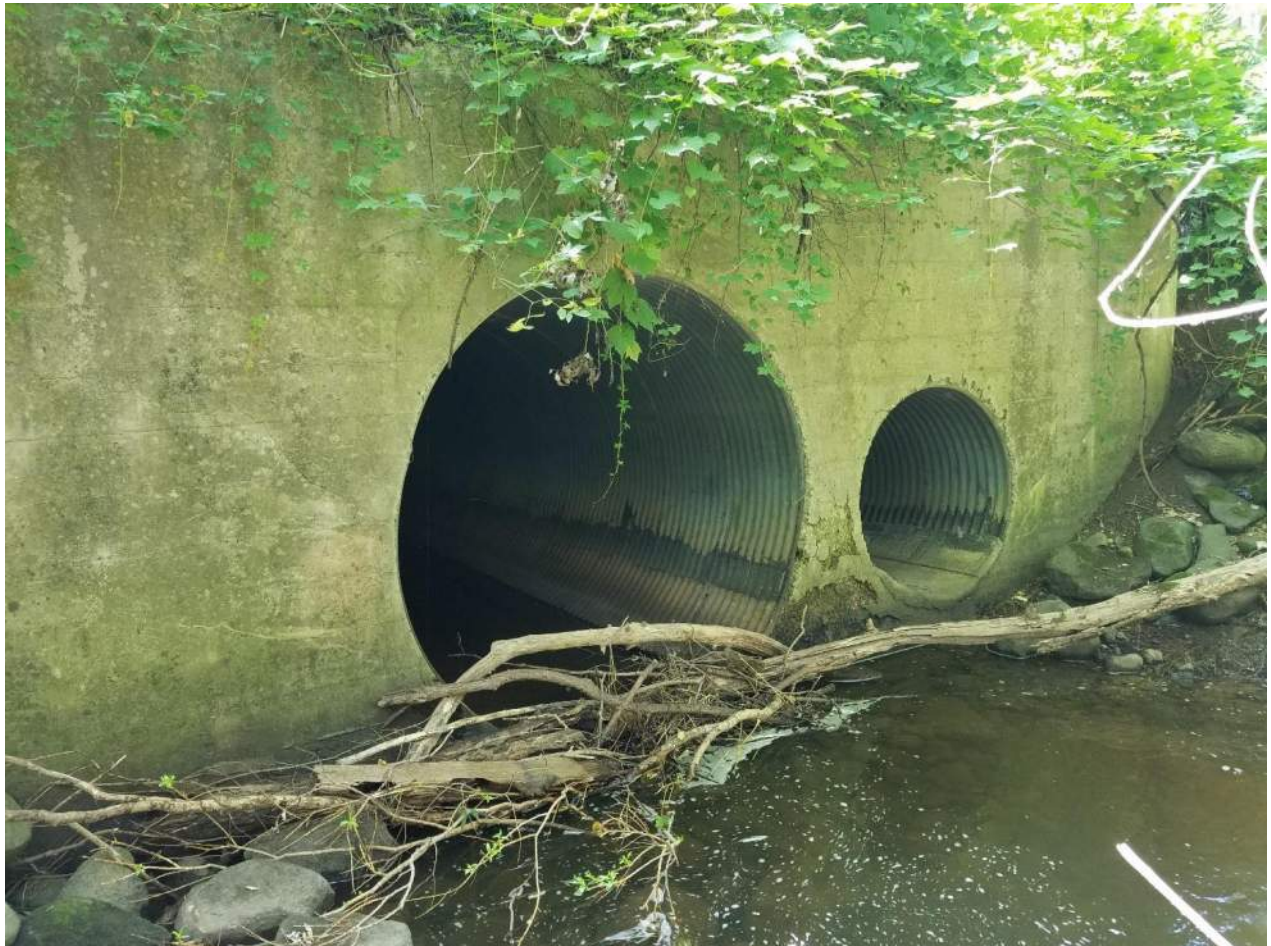
Pipes are in good condition. Recommend remove branches and debris from end of culverts that may be inhibiting flow.

Pipe Condition Both Pipes are in good condition.  
Recommend removing debris at end  
of culverts.
