#### Summary and Background

#### Base Bid AHU Replacement (Current Configuration)

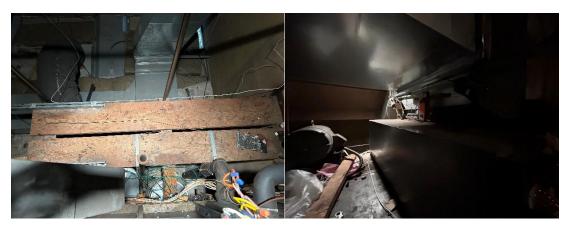
**Exhibit 2** – Work Platform and crawl space to access platform between AHU /Motor / Ductwork.

- Requires the replacement of existing platform in mezzanine, current platform does not meet requirements for safety and proper maintenance access. I-beams will need to be installed to secure platform and new AHU.
- Drop ceiling / duct removal in room behind for installation of new AHU additionally impacting the duration the Council Chambers would have to be closed.
- Asbestos abatement may be needed for pipe insulation removal.

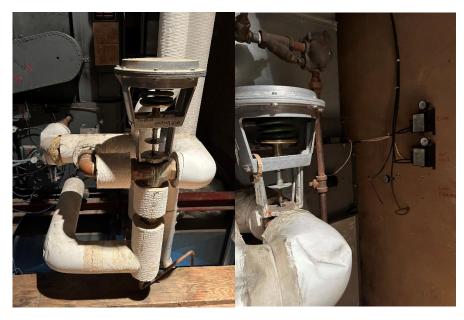
**Exhibit 4** – DX Coils to supply heat using pneumatic control may have to be switched out for VAV boxes.

Installation of variable air volume (VAV) boxes are required. This may impact the current building automation system (BAS) which may have to be updated for the compatibility and capacity of the system. The compatibility of the new AHU would be addressed in design. (GOOD, BETTER, BEST Options)

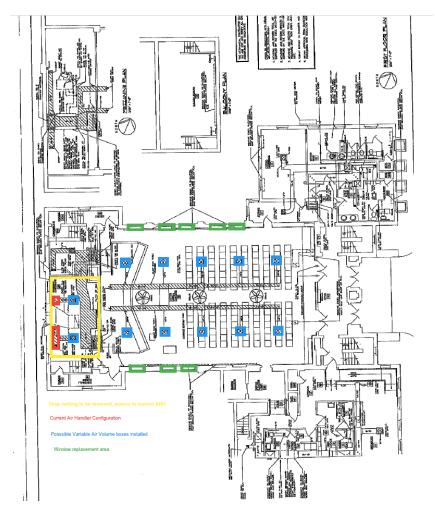
**Exhibit 5** – Plan of affected area with this option.

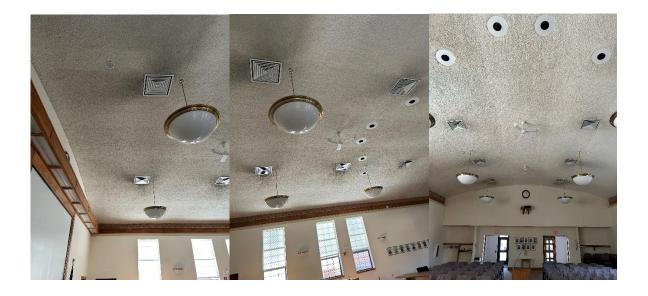
Removal of popcorn ceiling in the Common Council Chambers, the plaster underneath the popcorn ceiling contains asbestos and would have to have an asbestos abatement. New options for modernization of the ceiling could include ceiling clouds, perimeter soffits, and different lighting options. Replacement of the ceiling would also improve the acoustics of the Council Chambers; design would be needed to cover best options available to the City of Mequon.

- Modernization including dropped ceiling clouds, perimeter soffits, range of material, color, and lighting options.
- Aesthetically pleasing.
- Fixes water damaged areas of the ceiling.

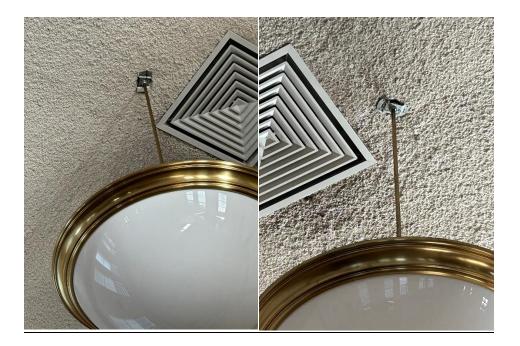
#### Lighting Pendant Securing Failure:

Upgrade all existing fluorescent lighting (pendant/scone) with energy efficient LED lighting. Lighting controls to be upgraded to have capability of growing the Building Automation System (BAS). Existing pendant lighting integrity is questionable, the fluorescent tubes within the current lighting system are dated, replacement bulbs will become obsolete in the near future.

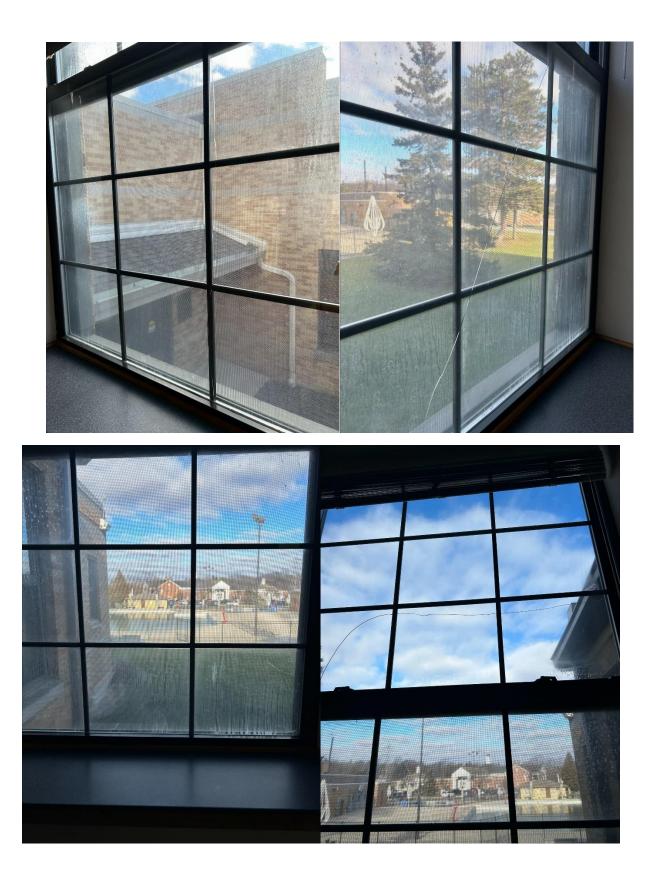
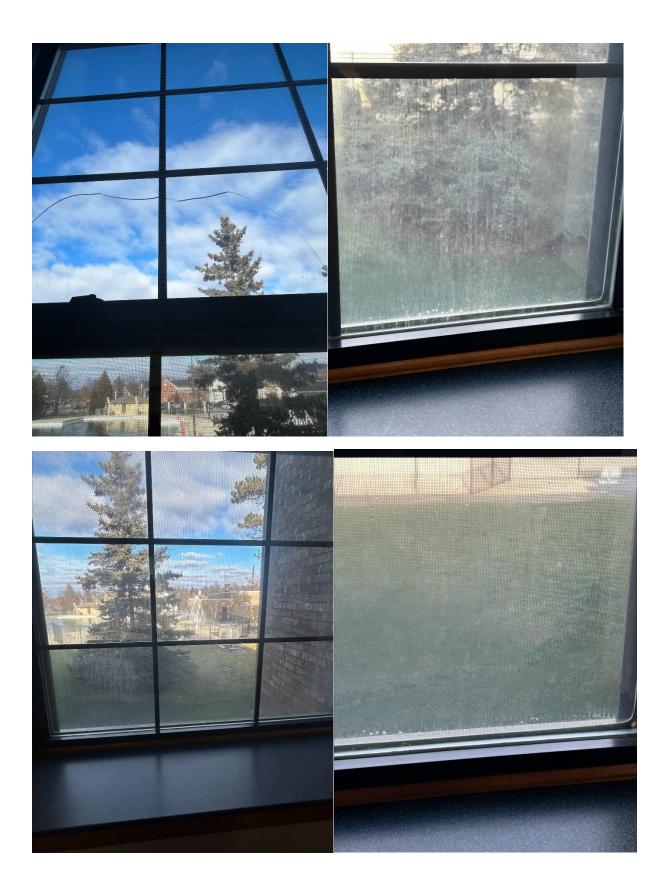
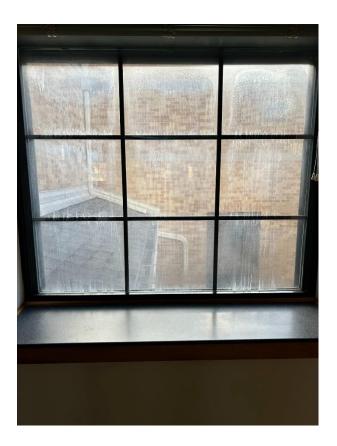
Design and replacement of the (8) current windows in the Council Chamber. The current window seals are damaged, and panes are broken, windows should be replaced with the HVAC project. New windows would be approved by the Landmark Commission and improve the energy efficiency of the Council Chambers while adding to the overall aesthetics of the Council Chamber.

- Energy efficiency resulting in reduced heating / cooling costs.
- Current windows need to be replaced; every seal in the windows is broken letting air pass through, multiple windows are cracked, spring tensioners are not working cracking the windows even further.
- New windows would be approved by the Landmark Commission, as the current windows are not.
- Cost savings compared to increasing the cost of needed replacement in the future.

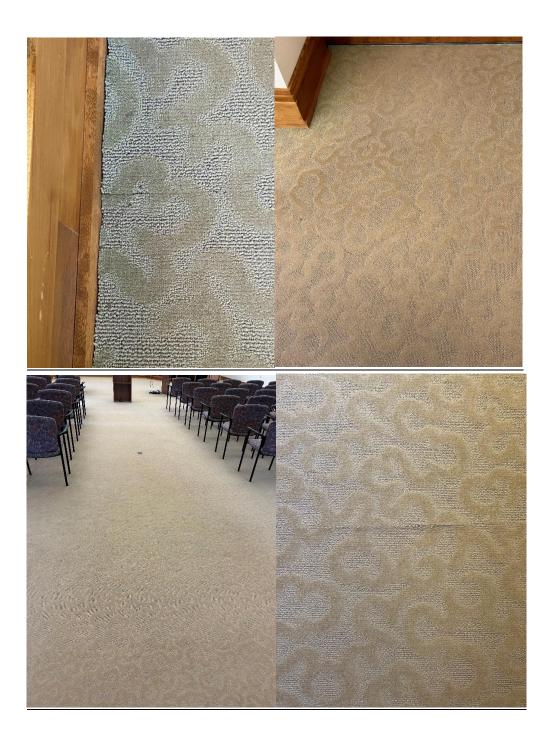
Current Carpet Worn and Peeling (staining cannot be removed with carpet cleaning):

Removal of approximately 4000 square feet of carpet down to the plywood underlayment, the plywood underlayment is encapsuling asbestos tile and cannot be removed without abatement. Option A would replace the carpeting with hardwood flooring with the City of Mequon logo and/or compass in the center near dais. This option would require acoustical ceiling modifications to limit echoing in the chambers. Option B would replace the carpet with carpet squares that could be replaced as worn or damaged (ex: blood drive). Carpet tiles have unlimited options for solid colors to patterns.
